Storage rack assembly at W&M : Feb 24- Mar 6, 2025

- Assembling the storage rack at W&M
- Loading lead in the segment plate on the storage rack
- Observation on the sagging of the storage rack with lead in it
- Measurement of the sagging of the segment plates on the storage rack and in the A-T box
- Main detector and shower-max rings are in the high bay at W&M

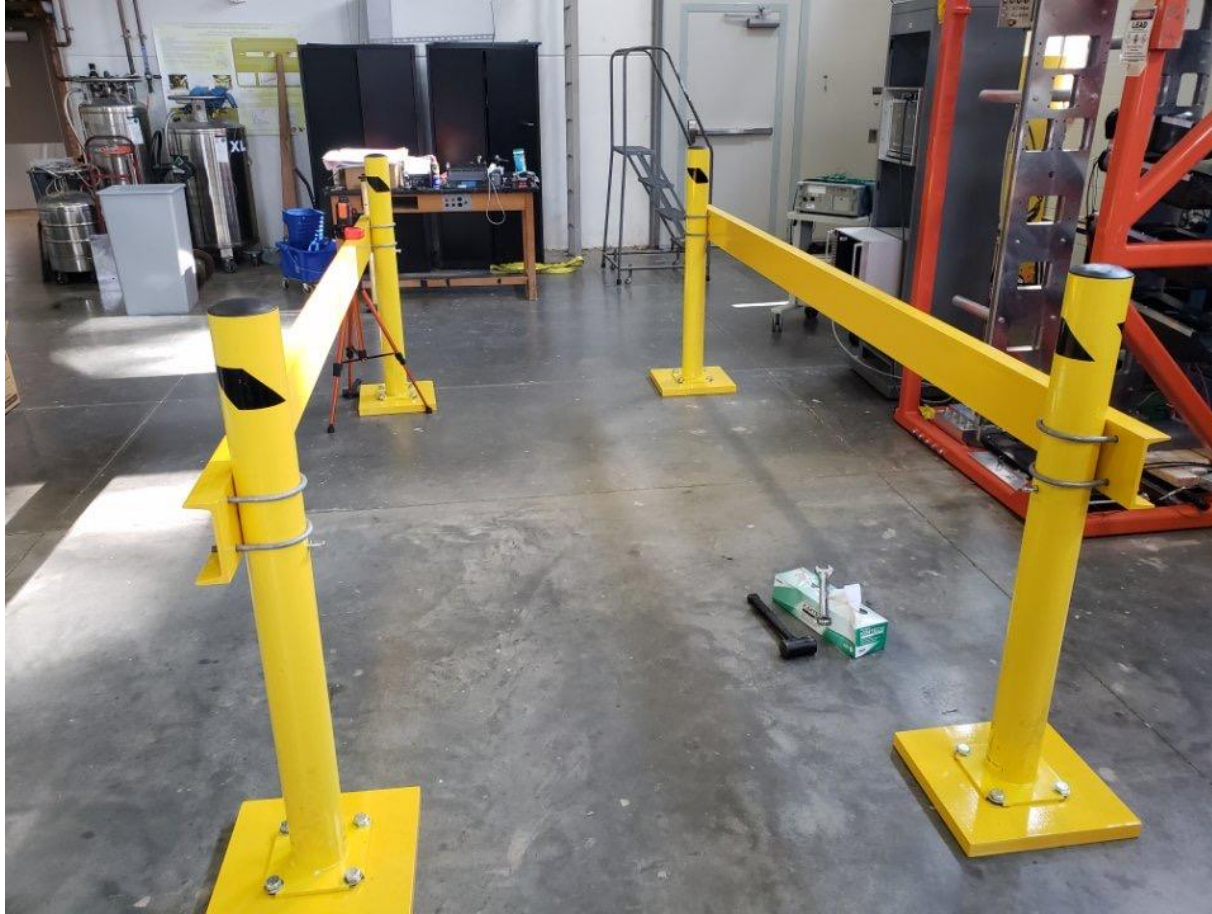
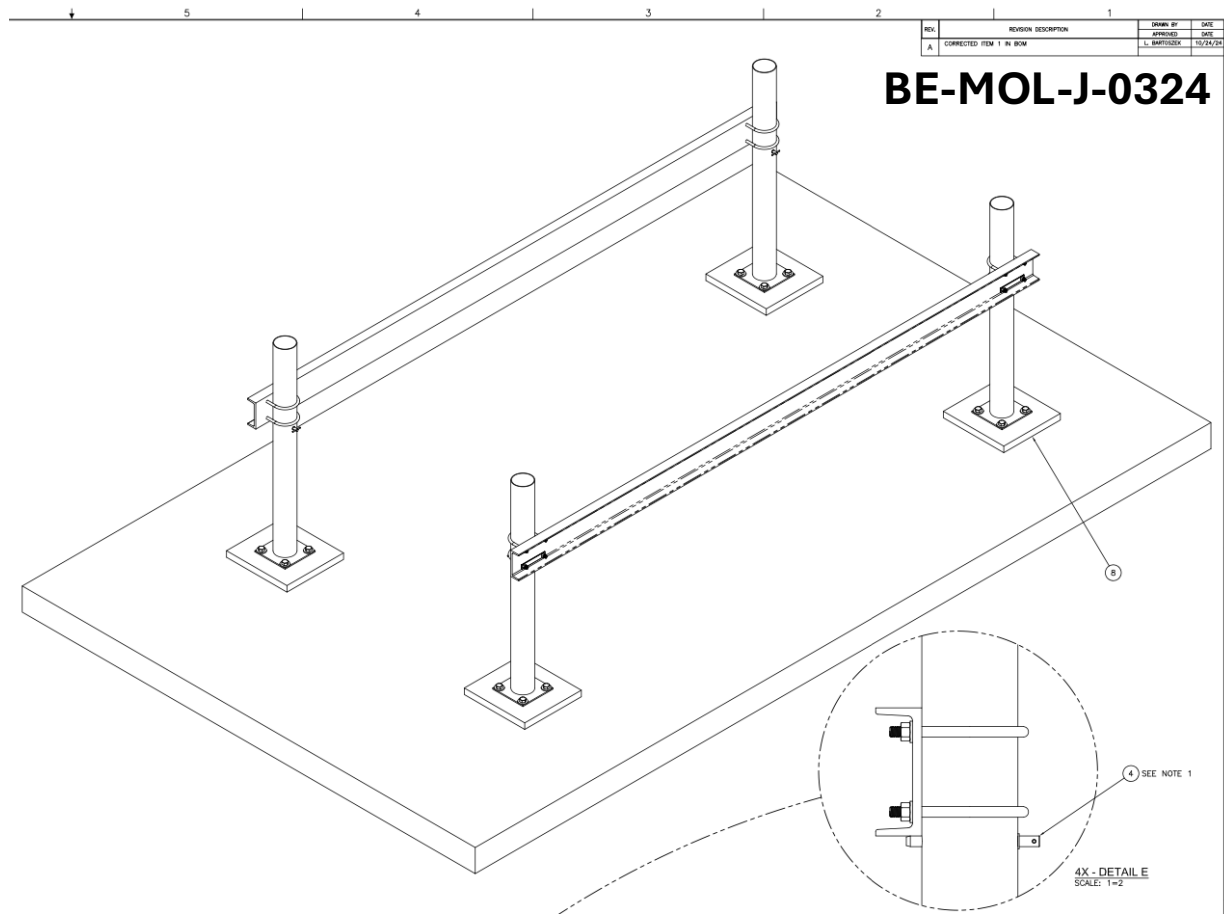
- Assembled one storage rack at W&M
- Took about half a day to complete the entire structure
 - The bollard whole structure was not lining up with the base plate
 - Will opened up the slots in the bollard
- Did not precisely align the rails, only measured the distance between the base plates

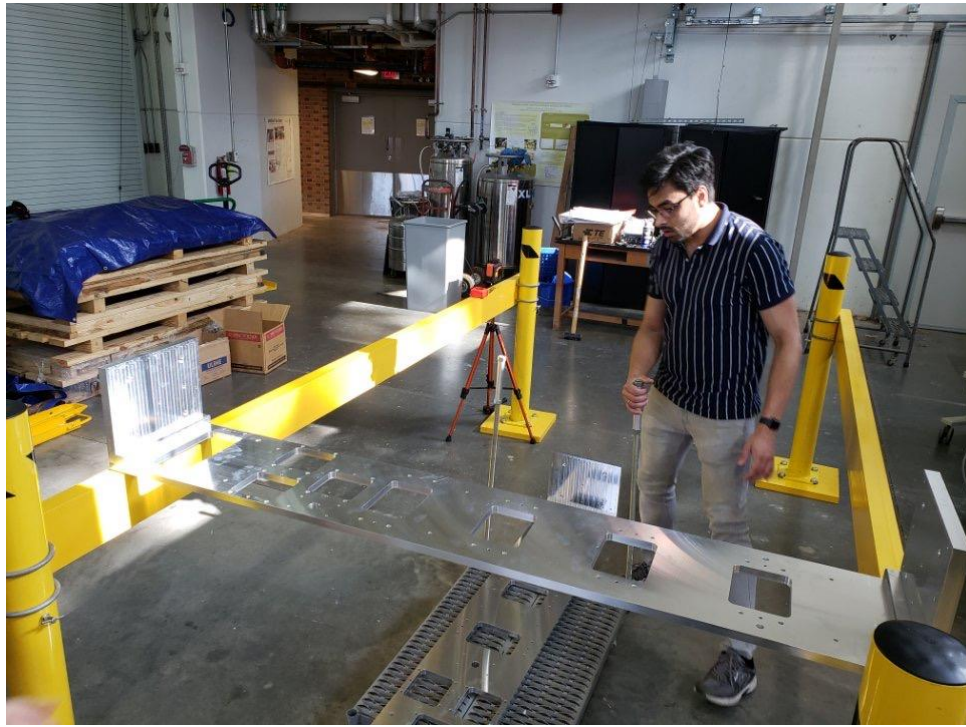
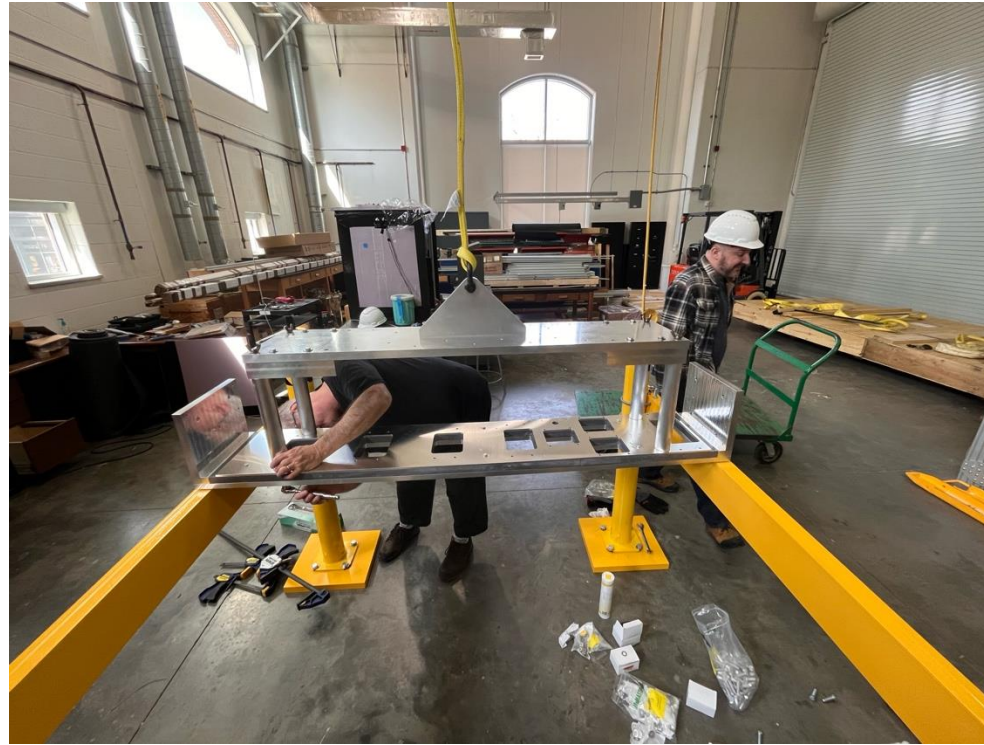
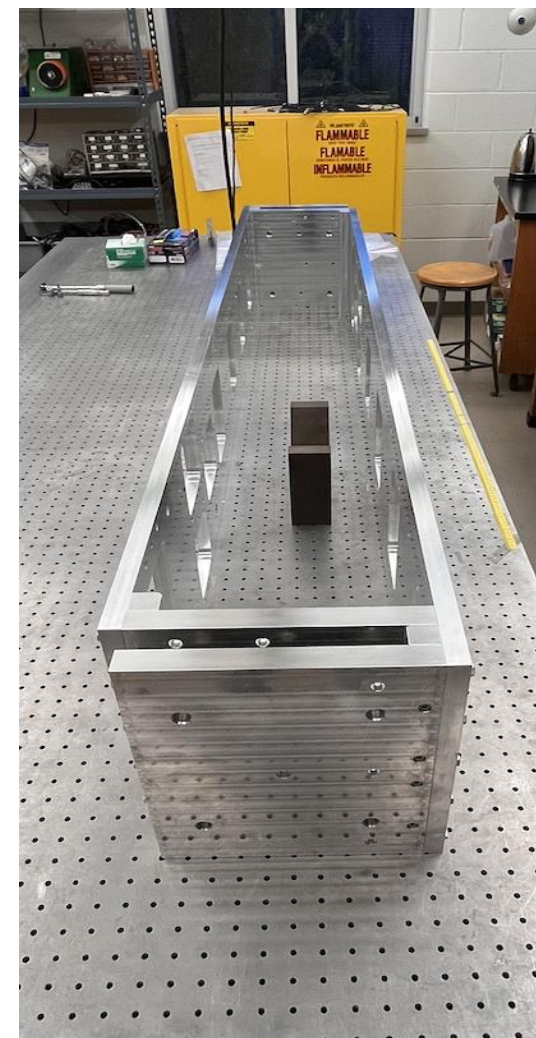
- Placed the U structure on the storage rack
- Used the lead lifting fixture to load the lead into the segment plate on the storage rack
- Used the stiffener plate and the module lifting boss (lifting lugs) to sandwich the lead in between the segment plate and the stiffener plate
- Started seeing sagging of the segment
- Had to use the segment lifting fixture to place the Pb corner bars and also, we found out that due to the sagging, the holes of the segment lifting fixture is not lining up with the module lifting lugs

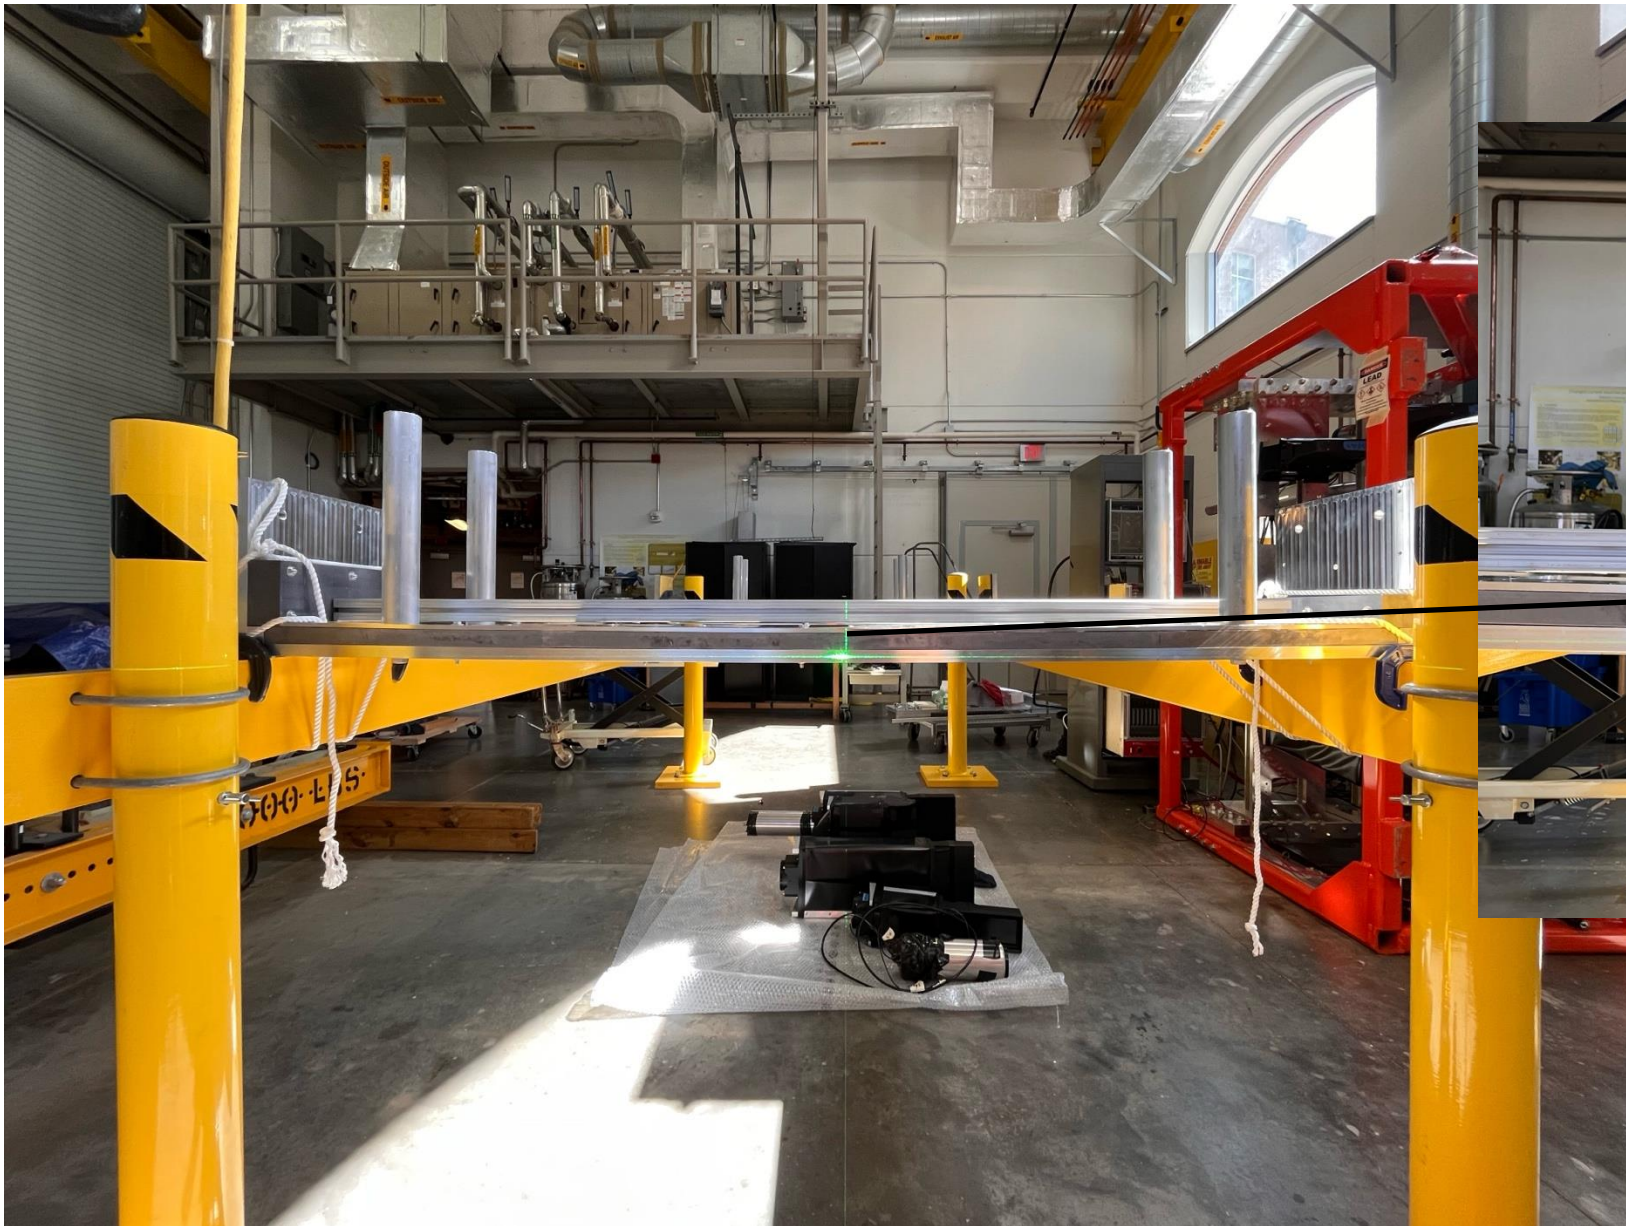
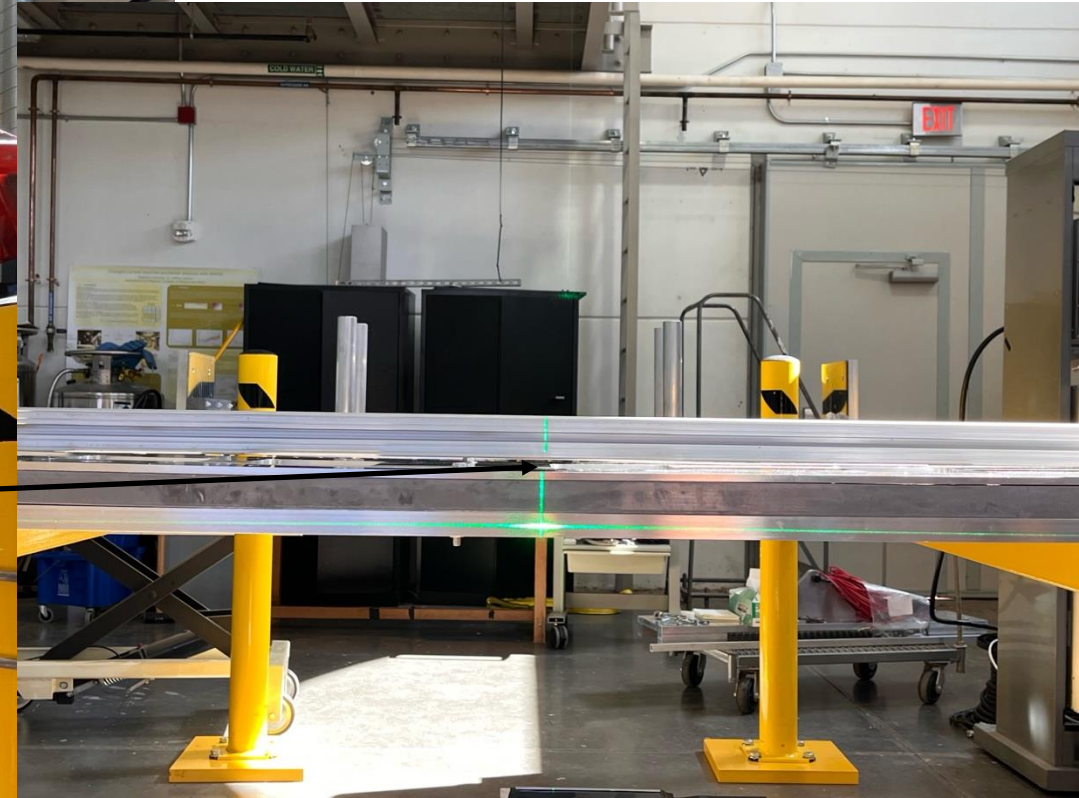
- Used a 80-20 bar to measure the sagging at the center of the segment
- ~ 8 mm gap between the bottom of the 80-20 bar and the top of the stiffener plate

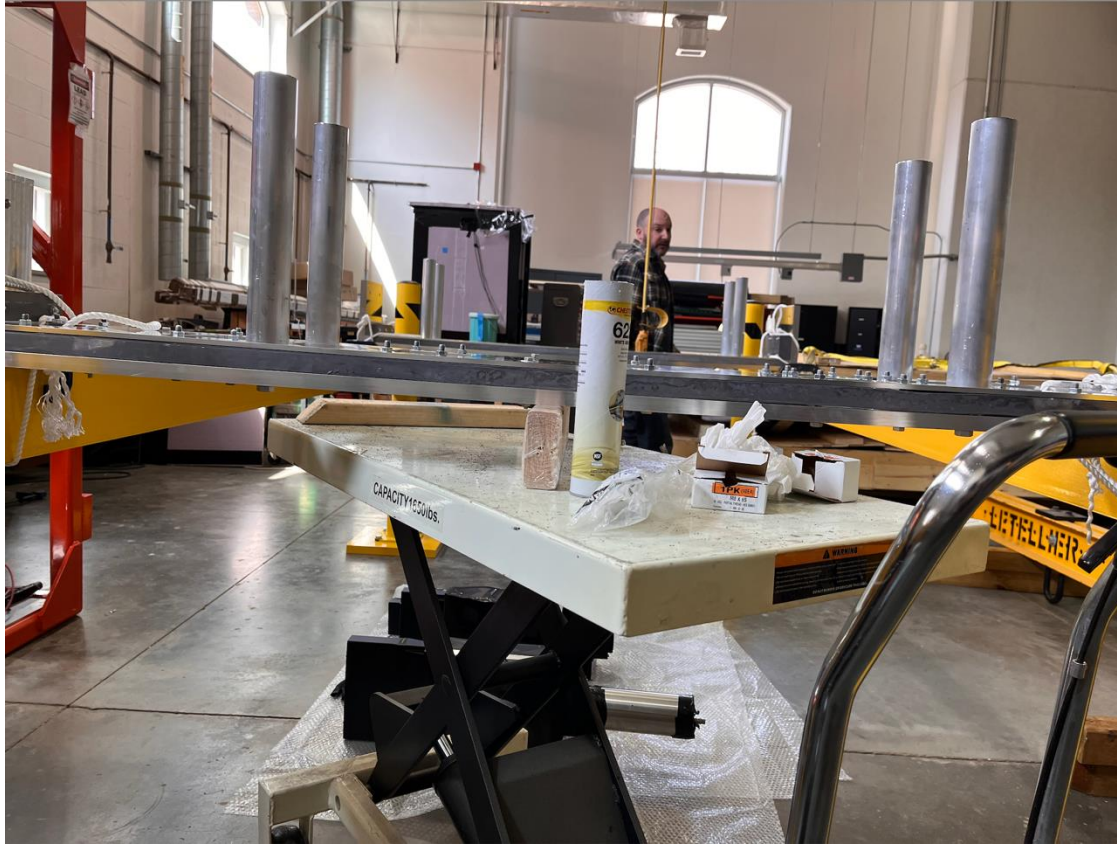
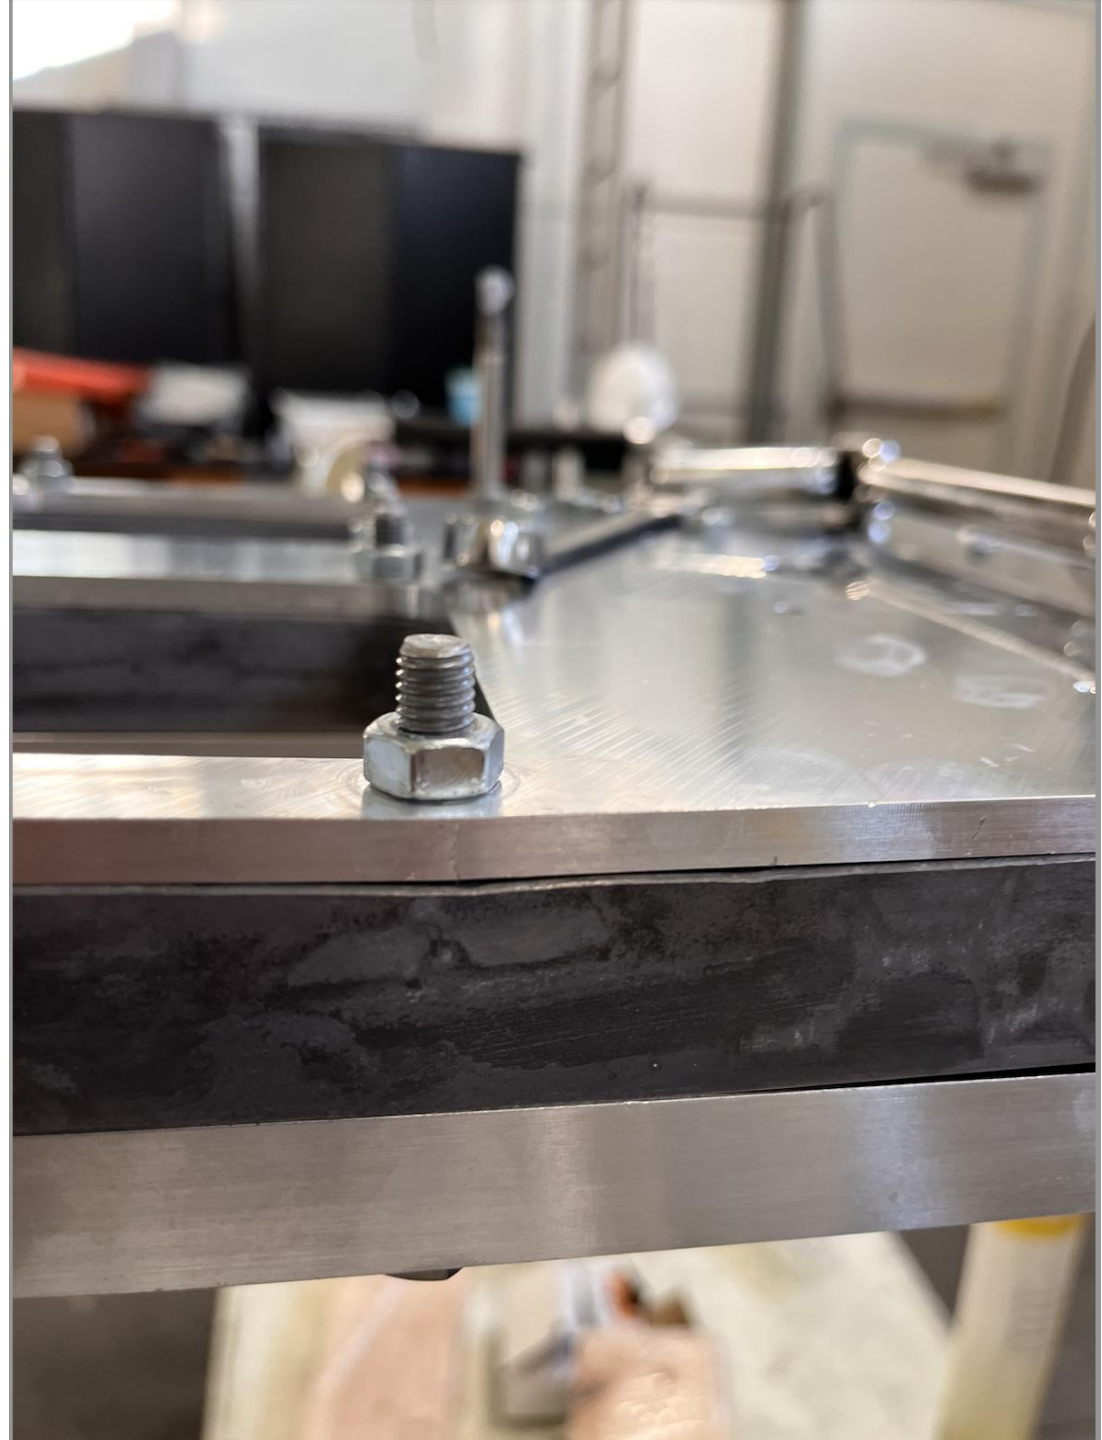
- Used a lifting table to support the segment plate (with Pb in it) and started fastening the M8 SS bolts using torque value ~ 100 lb-in
- Did not use washers with the M8 bolts
- Found cracks in SEG-II near the Ring 5 region

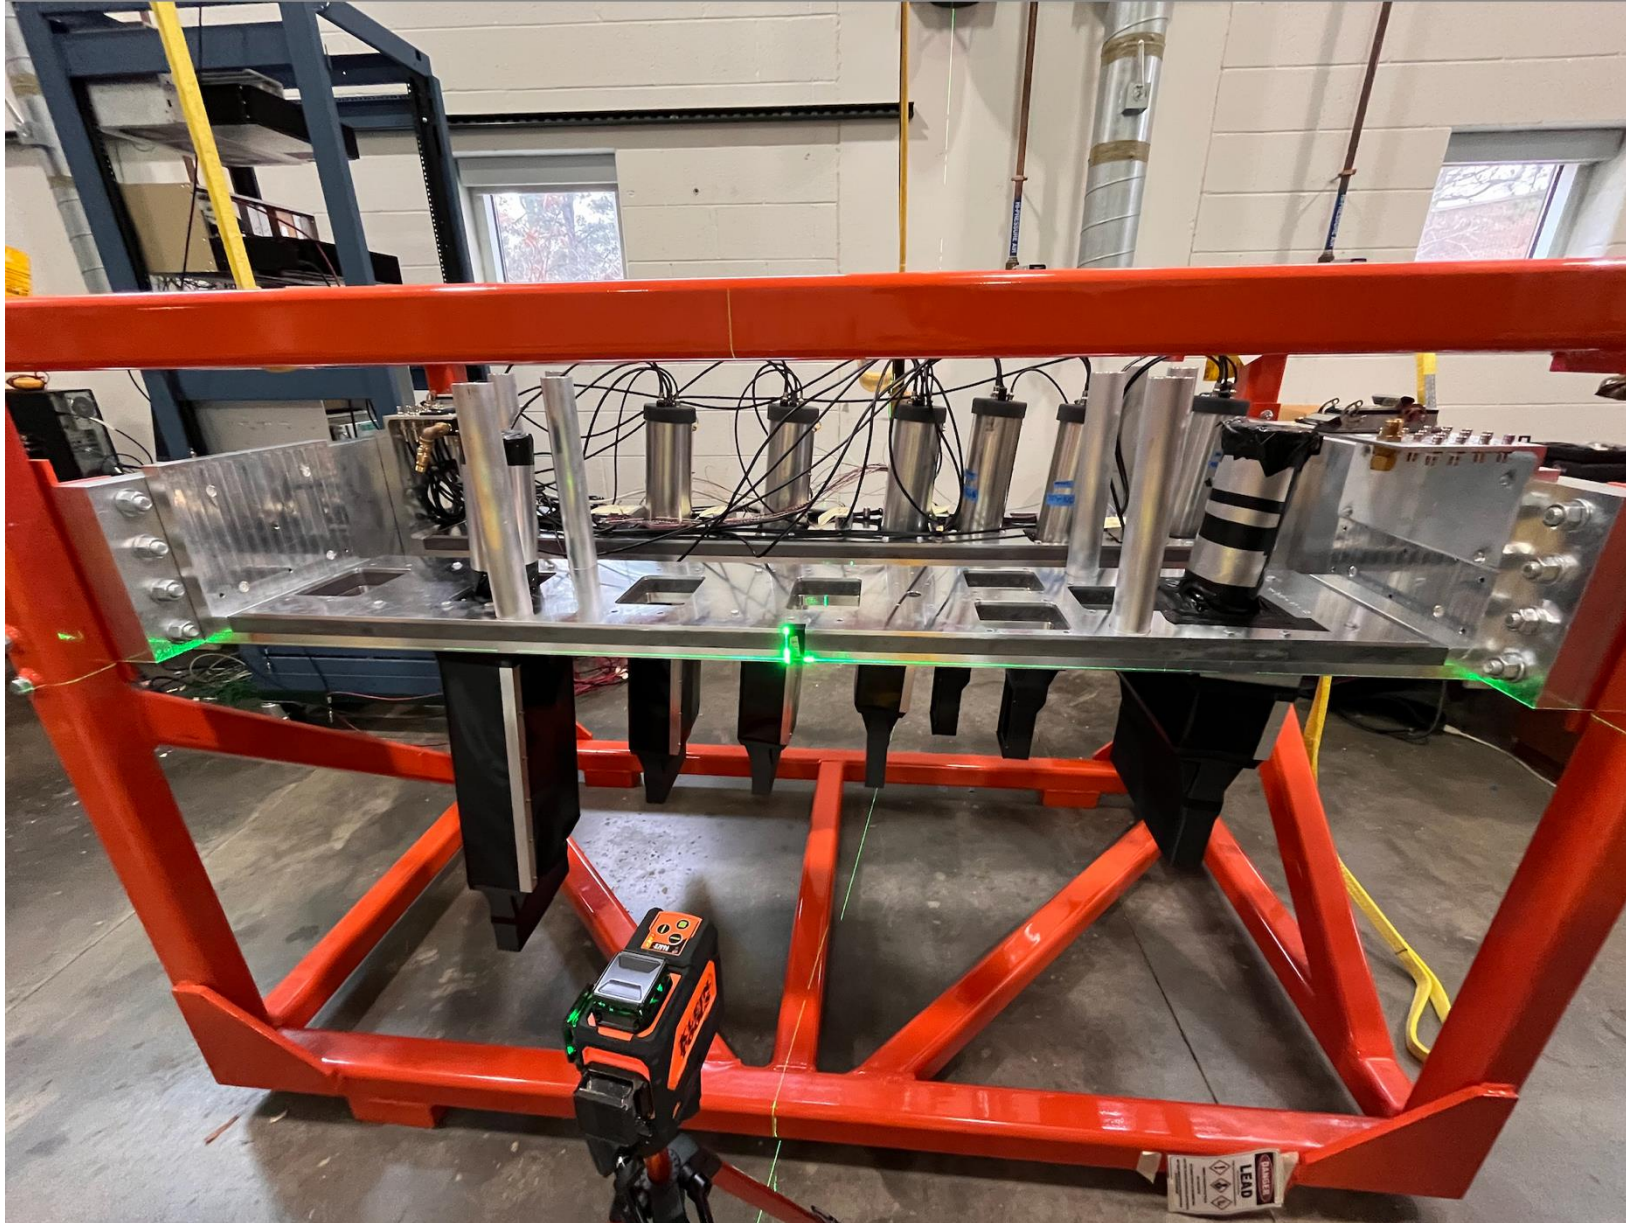
Measurement in the A-T box

- Observed a sagging of 4.5 (± 0.4) mm at the center of the SEG-I where 6 modules were present, but the M8 Al bolts were not fastened to the torque values
- Observed a sagging of 4.2 (± 0.4) mm at the center of the SEG-0 where only 2 modules were present and no other M8 bolts were engaged
