TITLE: MOLLER Spectrometer – Downstream Torus Magnet Prototype Coil Report on Fabrication and Testing

DOCUMENT NUMBER: PMAG0000-0100-R0035

DATE: April 28, 2023

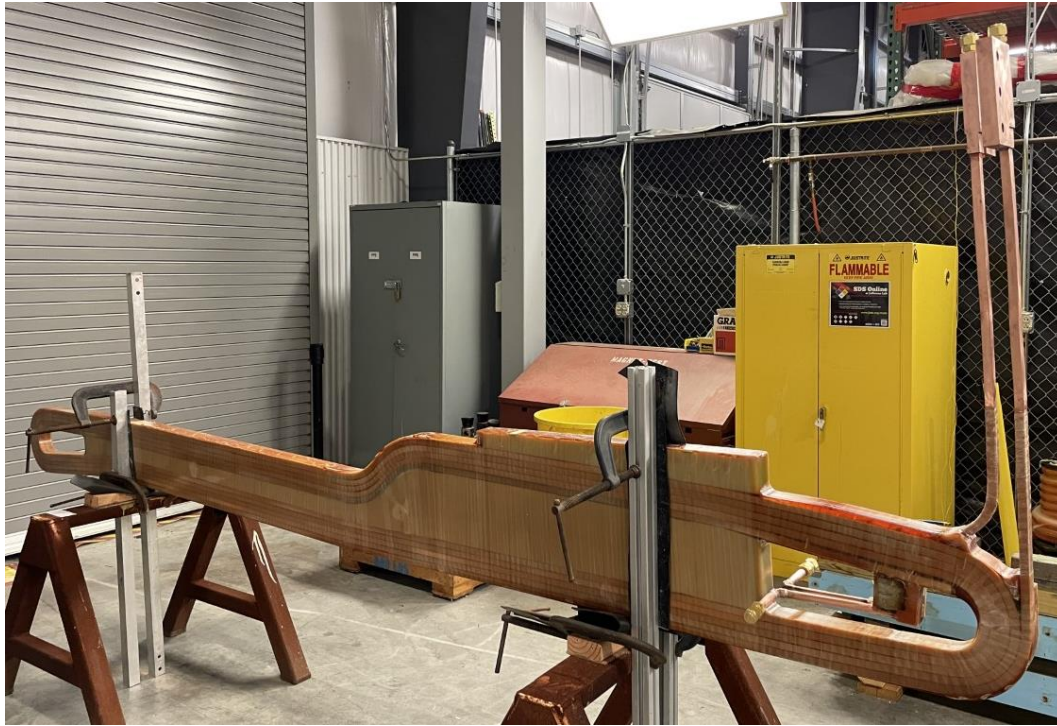
Figure 2 - Baseline Test Configuration for SC4-01

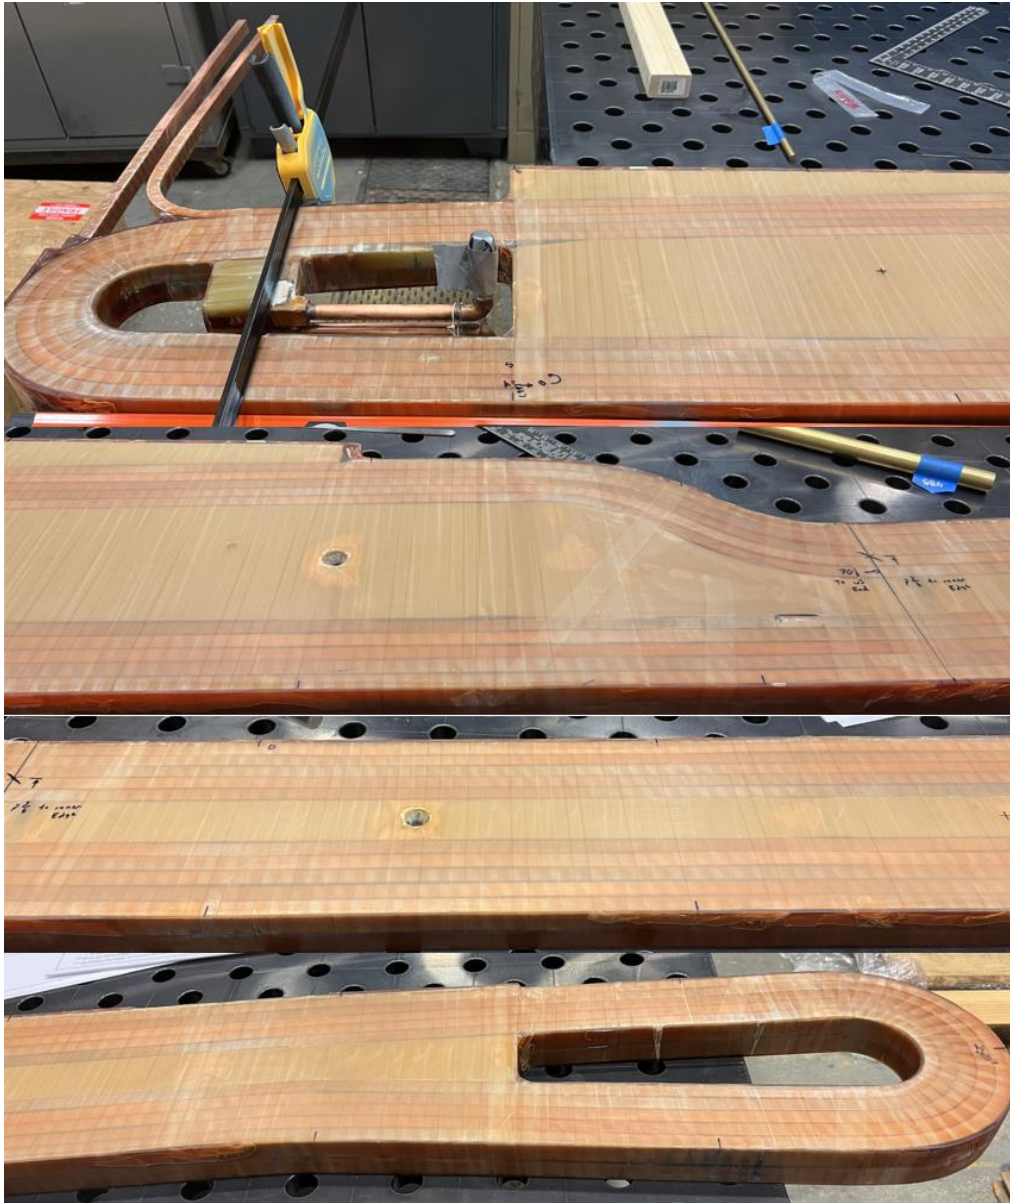
Fiberglass Taping Overall, the taping is fairly consistent. There are very few regions of “brighter white” color, which indicates there are few regions with significant tape overlap. As previously stated, it appears that some tape may have been “pinched” near the DS turn, causing damage to the resin.

Conductor Delamination There is limited delamination throughout the coil at the conductor-G10 interface. Similar to the delamination observed in the center of the G10 blocks, much of the observable delamination at the conductor-G10 interface occurs near the middle of the coil, where the coil tightens and narrows in size. There is also some delamination near the DS end, near where the coil has a slight bend. In flat areas, delamination at the conductor-G10 interface is almost non-existent.

Threaded Lifting Points The threaded lifting points have significant discoloration and delamination around the feature. The internal threads themselves do not appear to be

significantly damaged, but there does appear to be signs of very light debris, potentially indicating that the threads are wearing out during continued use and continued removal of lifting hardware. In the future, a threaded silicon bronze insert should be used and permanently installed within the coil G10. In doing so, the G10 will not experience continued removal of lifting hardware, ultimately improving the integrity of the threads.

Figure 6 - SC4-01, Upstream End (Top of Figure) Moving Towards the Downstream End (Bottom of Figure), Taken March 13th, 2023

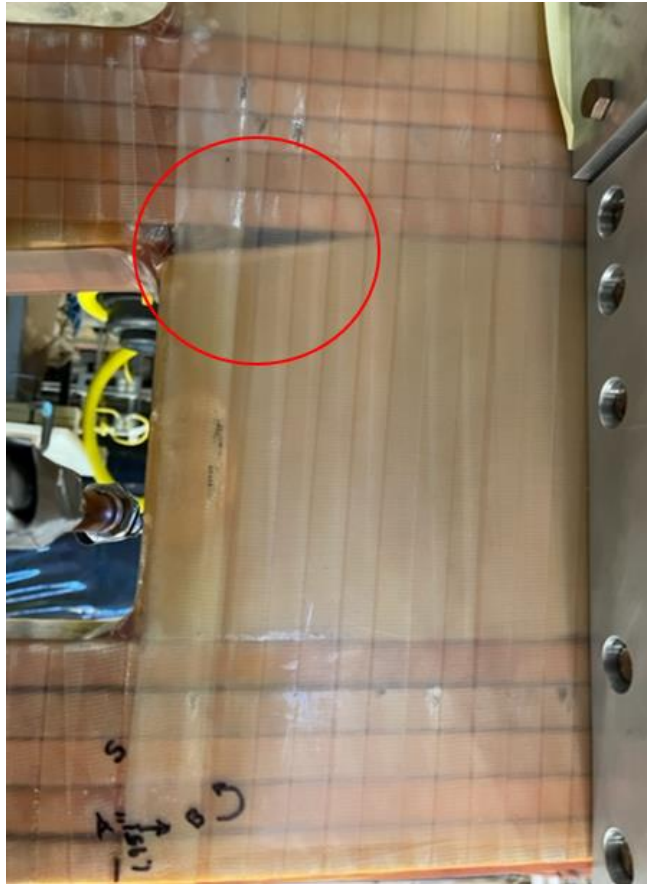
Figure 7 - Machining Error on the Inner G10 block of SC4-01, Upstream End, Right Side

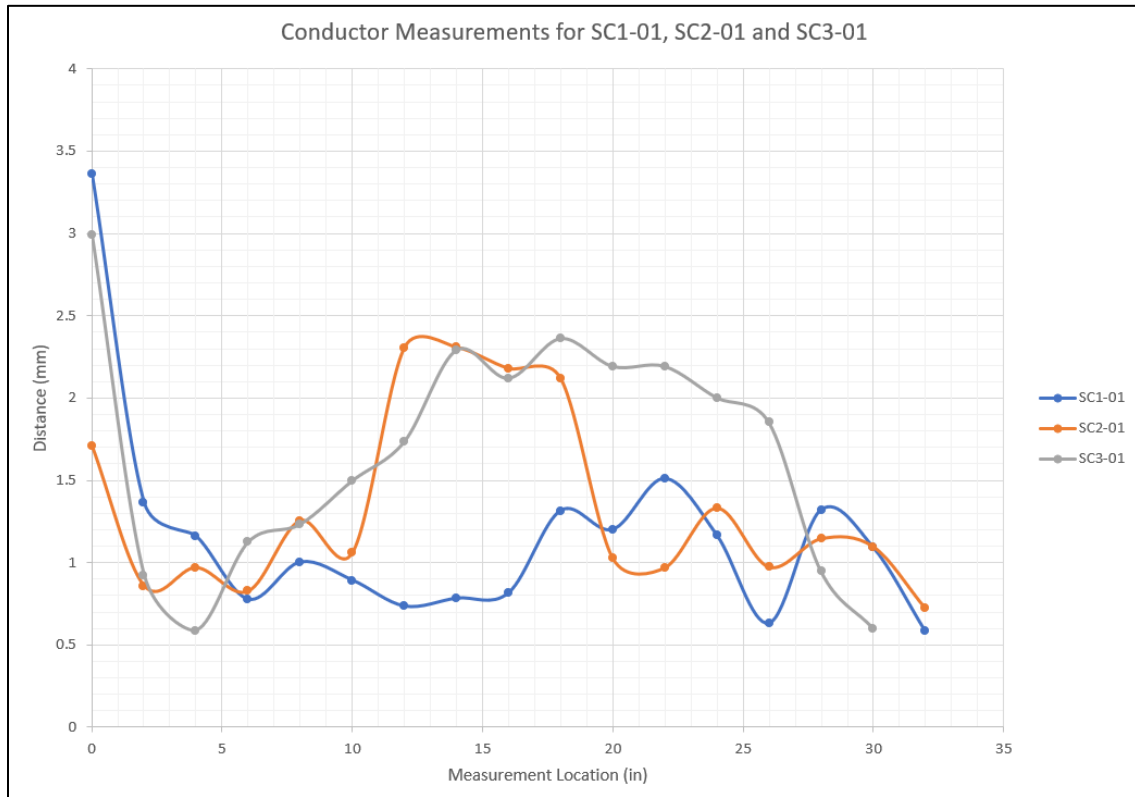
Figure 13 - Conductor Measurements Plot for SC1-01, SC2-01 and SC3-01

From the data shown in Figure 13, it appears that SC2-01 and SC3-01 likely had too much “post-wind bending”, which resulted in the central areas of the coil not being pressed against the mold wall along its full length (SC1-01 likely has less post-wind bending due to the lower stack height and reduced stiffness, relative to SC2-01 and SC3-01). The result for SC1-01 is quite good and it would be ideal to replicate those results for all production coils.

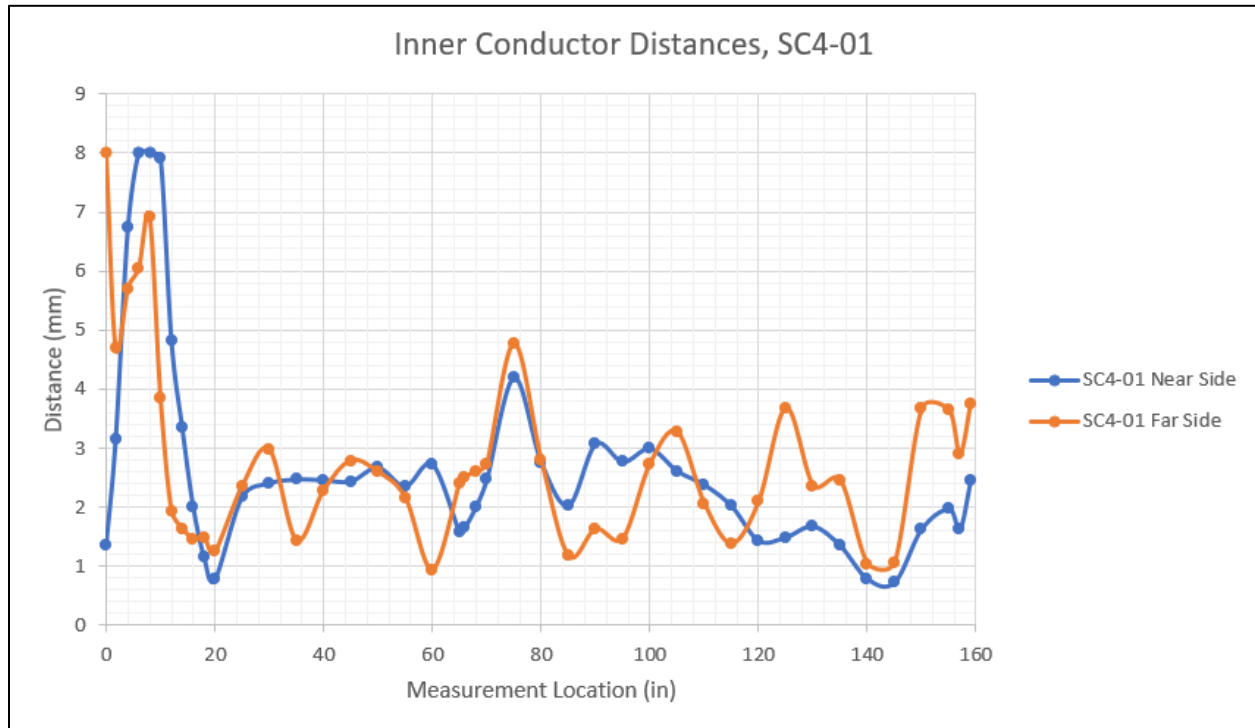
SC4-01 was measured a little differently than the other three coils. SC4-01 was secured such that the inner edge of the coil faced upwards. The “zero” position was defined as the tangent point on the US turn. The measurement points were located at relevant features along the coil’s inner edge, such as near turns, bends, etc. Additional measurement points were spaced uniformly (every 5 inches) along straight portions of SC4-01’s inner edge. In total, there were 42 measurement locations. The total distance of the measurement location from the zero position correlates to the total length along the coil’s inner path. Figure 14 shows some of the locations along SC4-01’s inner edge in order to highlight the overall scale and distribution of measurement locations. Both of the conductor stacks were measured on SC4-01, designated the “near side” and “far side” conductor, based on the orientation shown in Figure 15. Table 2 reports the measurements for SC4-01, which are plotted in Figure 16.

Figure 16 – Conductor Measurements Plot for SC4-01

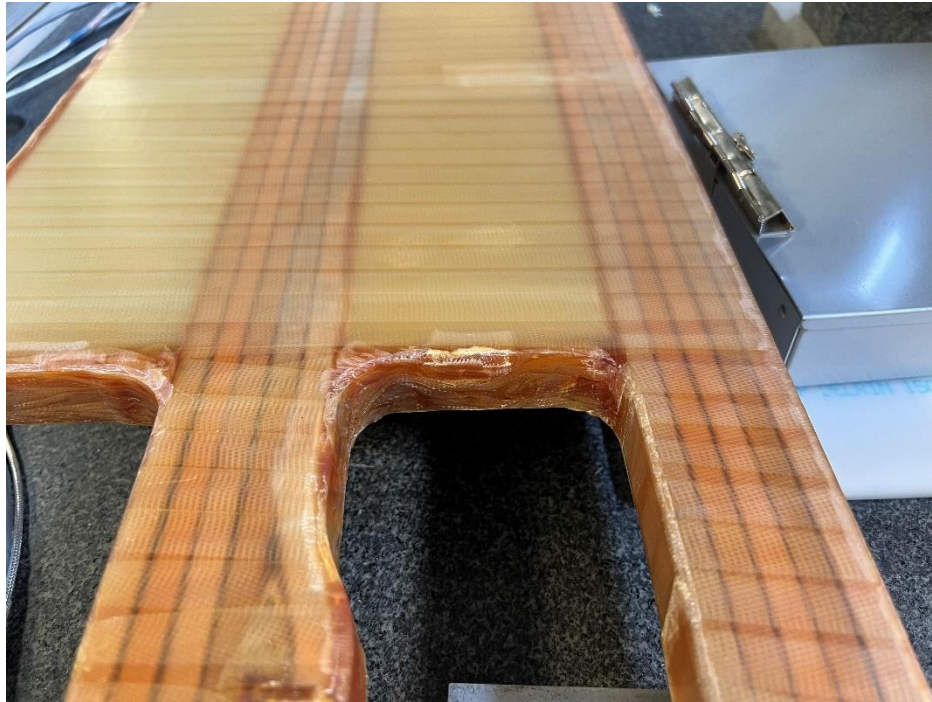
Figure 50 – Lead Side of SC2-01 at Cycle 0 (Start of Testing)

Figure 51 - Enhanced View of the Lead Side SC2-01 at Cycle 0 (Start of Testing)

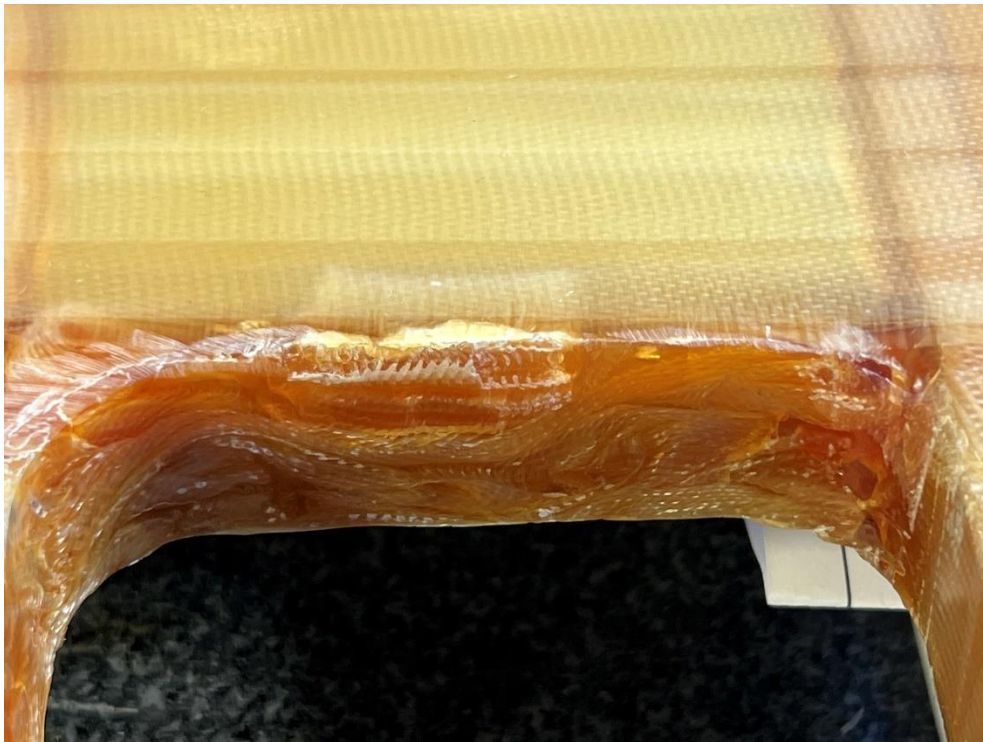
- For SC2-01, a beveled edge was added to the G10 blocks, particularly in way of the conductor-G10 interfaces. This reduced the stress in these regions, resulting in a stronger coil, which did not show breaking of bonds at the conductor-G10 interfaces that were observed at the delivery of the coils to JLab and significantly worsened after thermal cycling.

Figure 52 - Lead Side of SC2-01 at Cycle 80 (End of Testing)

Figure 53 - Enhanced View of the Lead Side SC2-01 at Cycle 80 (End of Testing)

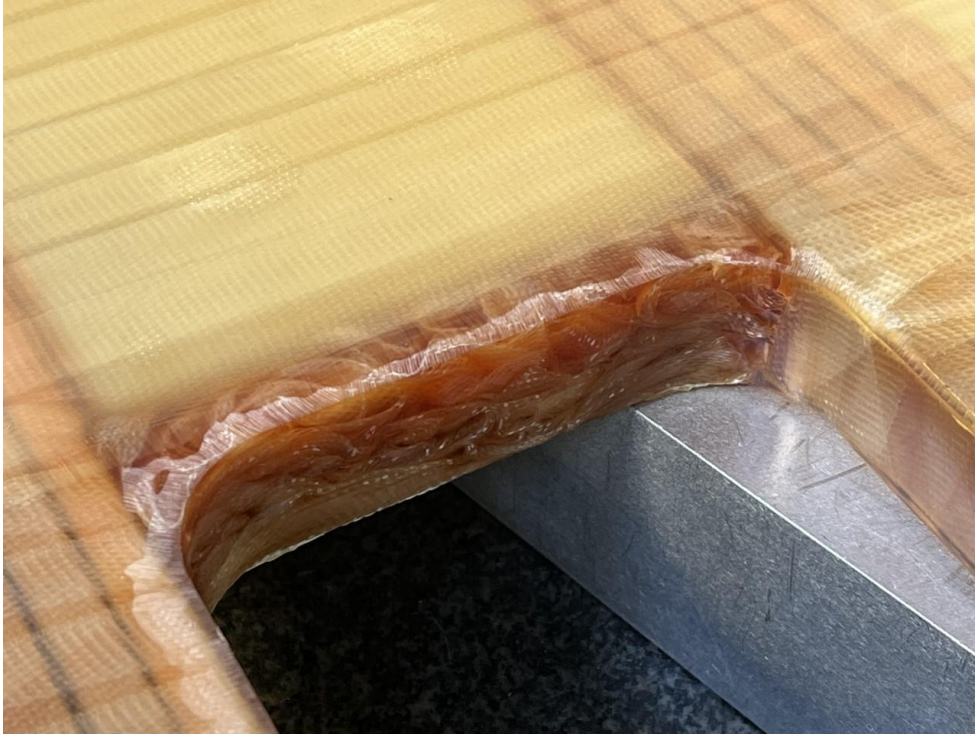
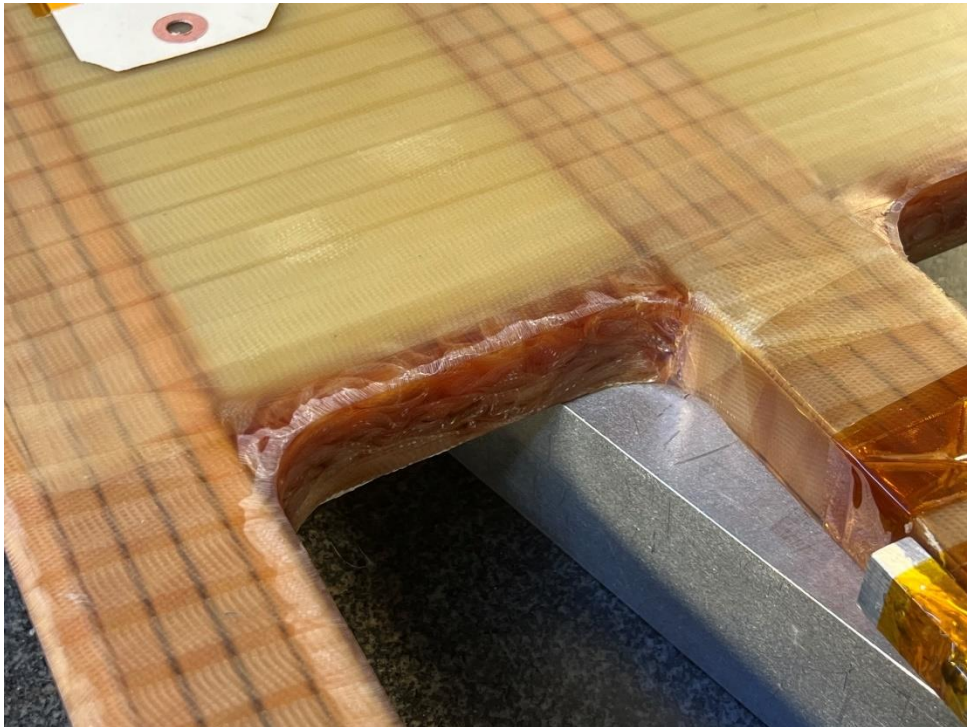
Figure 54 - Non-Lead Side of SC2-01 at Cycle 0 (Start of Testing)

Figure 55 - Non-Lead Side of SC2-01 at Cycle 80 (End of Testing)

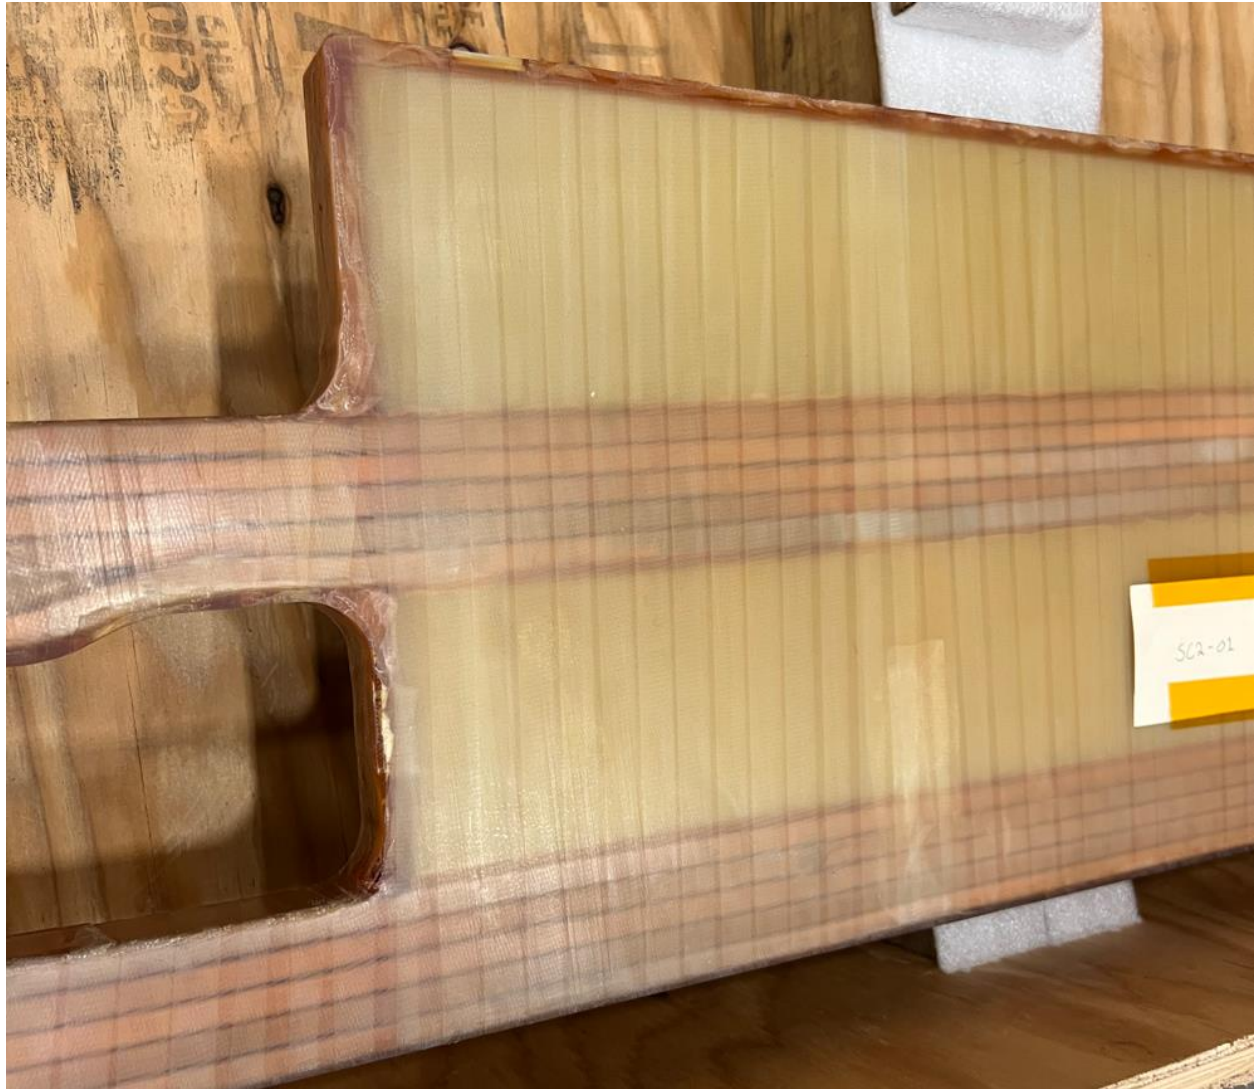
Figure 56 - SC2-01 After Thermal Cycling Testing on February 20, 2022

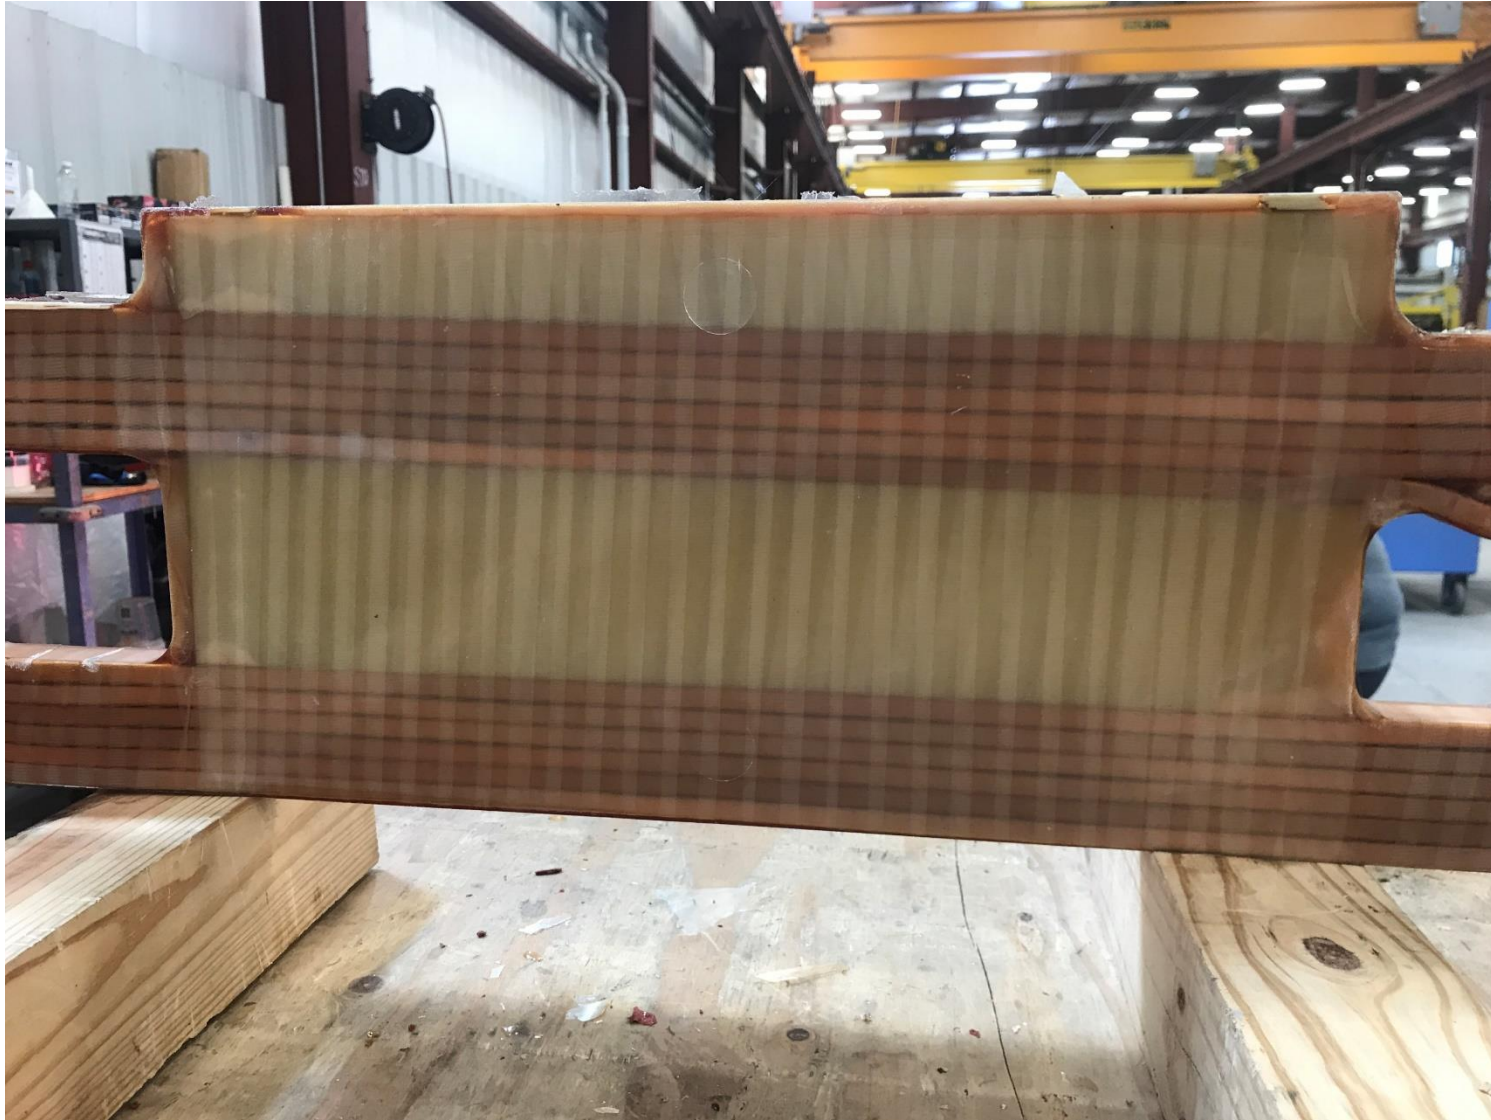
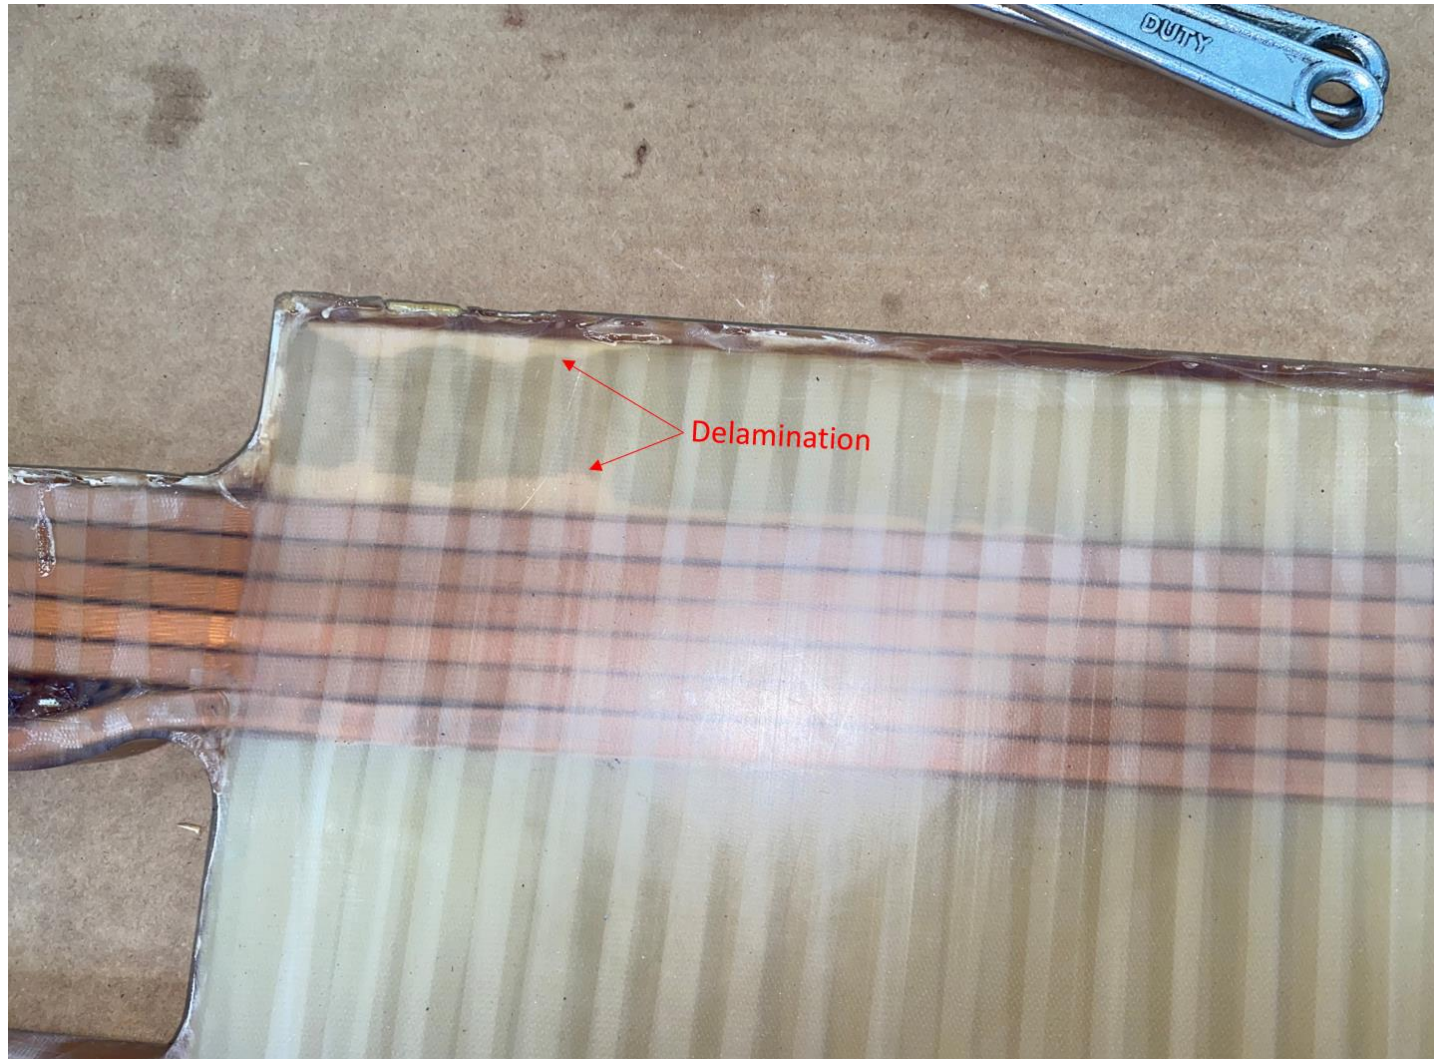
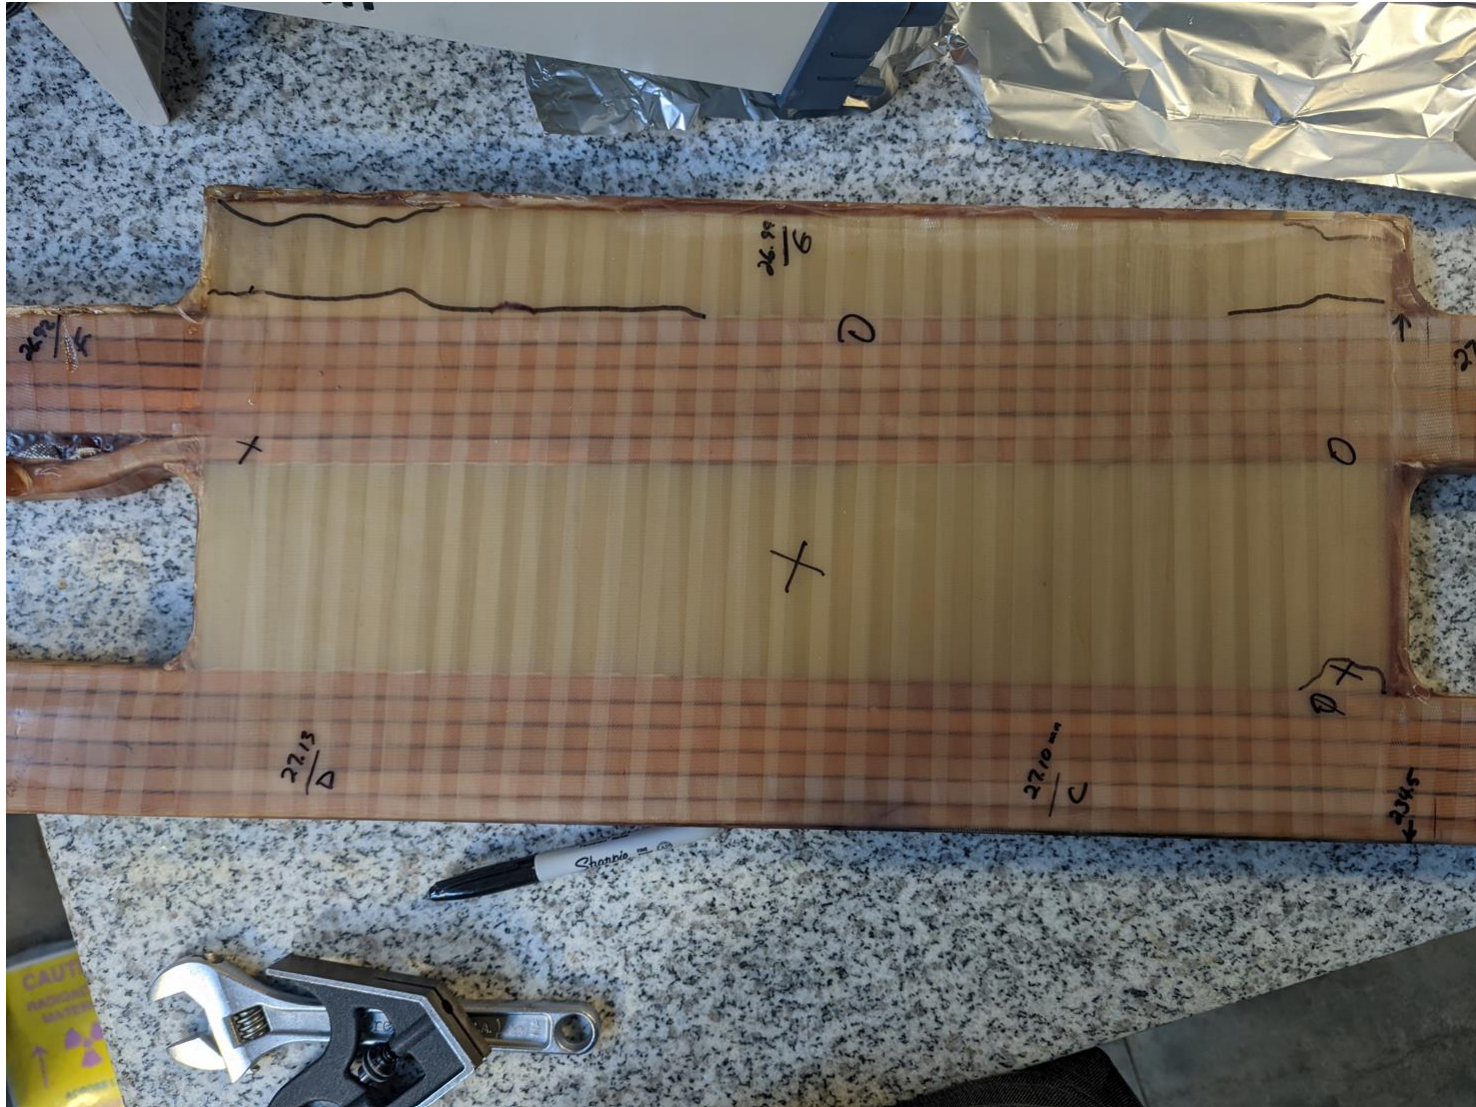
Figure 59 - SC3-01 Out of the Model on August 9, 2022

Figure 60 - SC3-01 Out of the Mold on August 17, 2022

Figure 61 - SC3-01 Before Thermal Cycling on September 5, 2022

Figure 62 - SC3-01 Before Thermal Cycling on September 13, 2022

Figure 63 - SC3-01 Before Thermal Cycling on September 13, 2022

Figure 64 - SC3-01 After Thermal Cycling on October 14, 2022

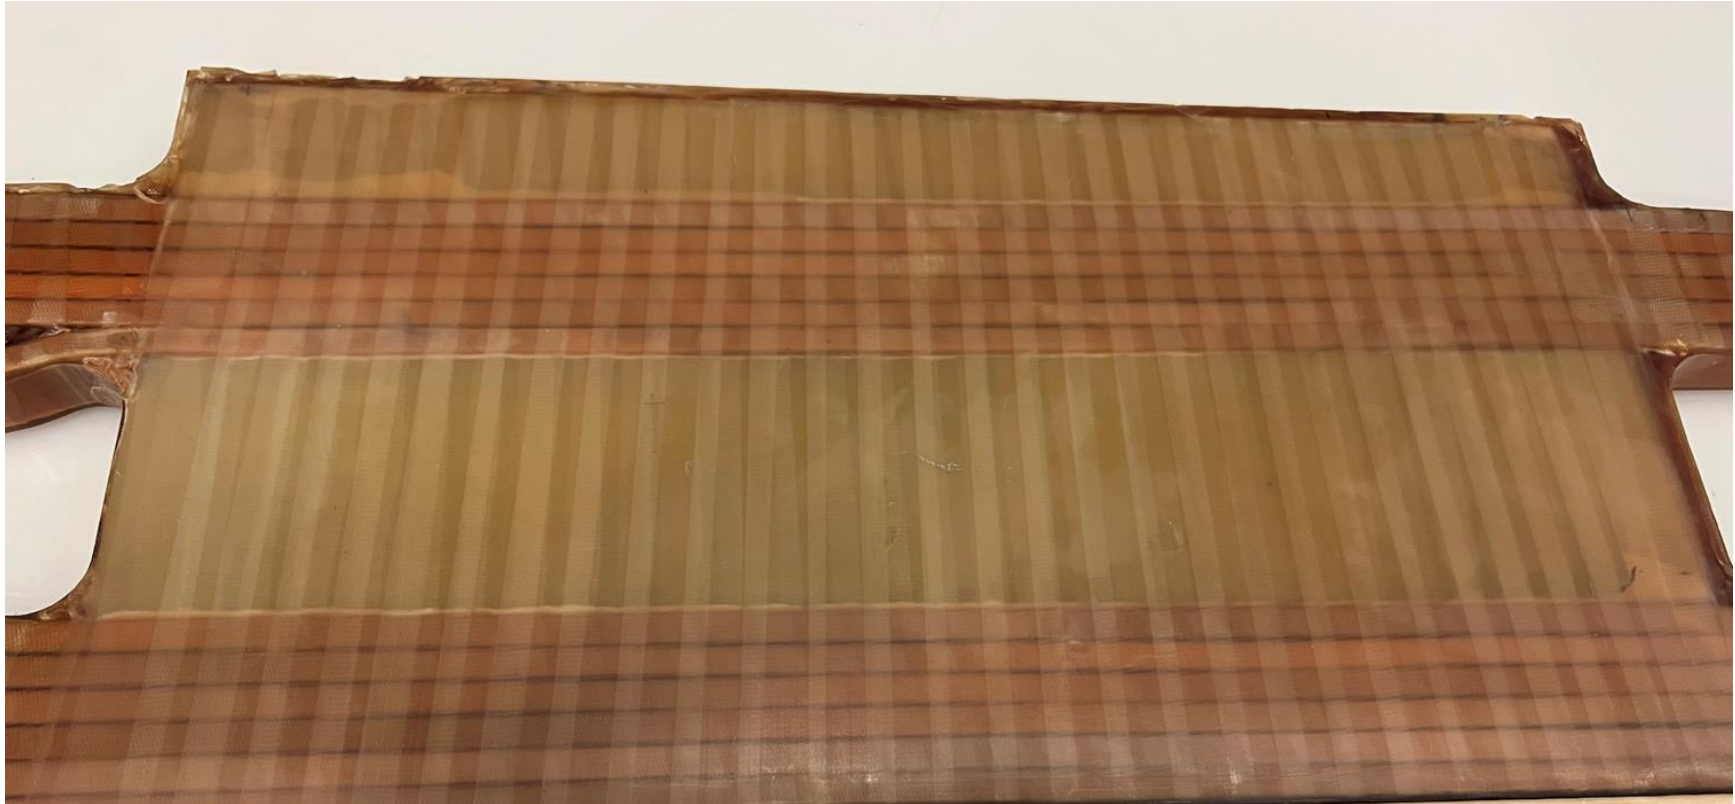
Figure 65 - SC3-01 on February 20, 2023

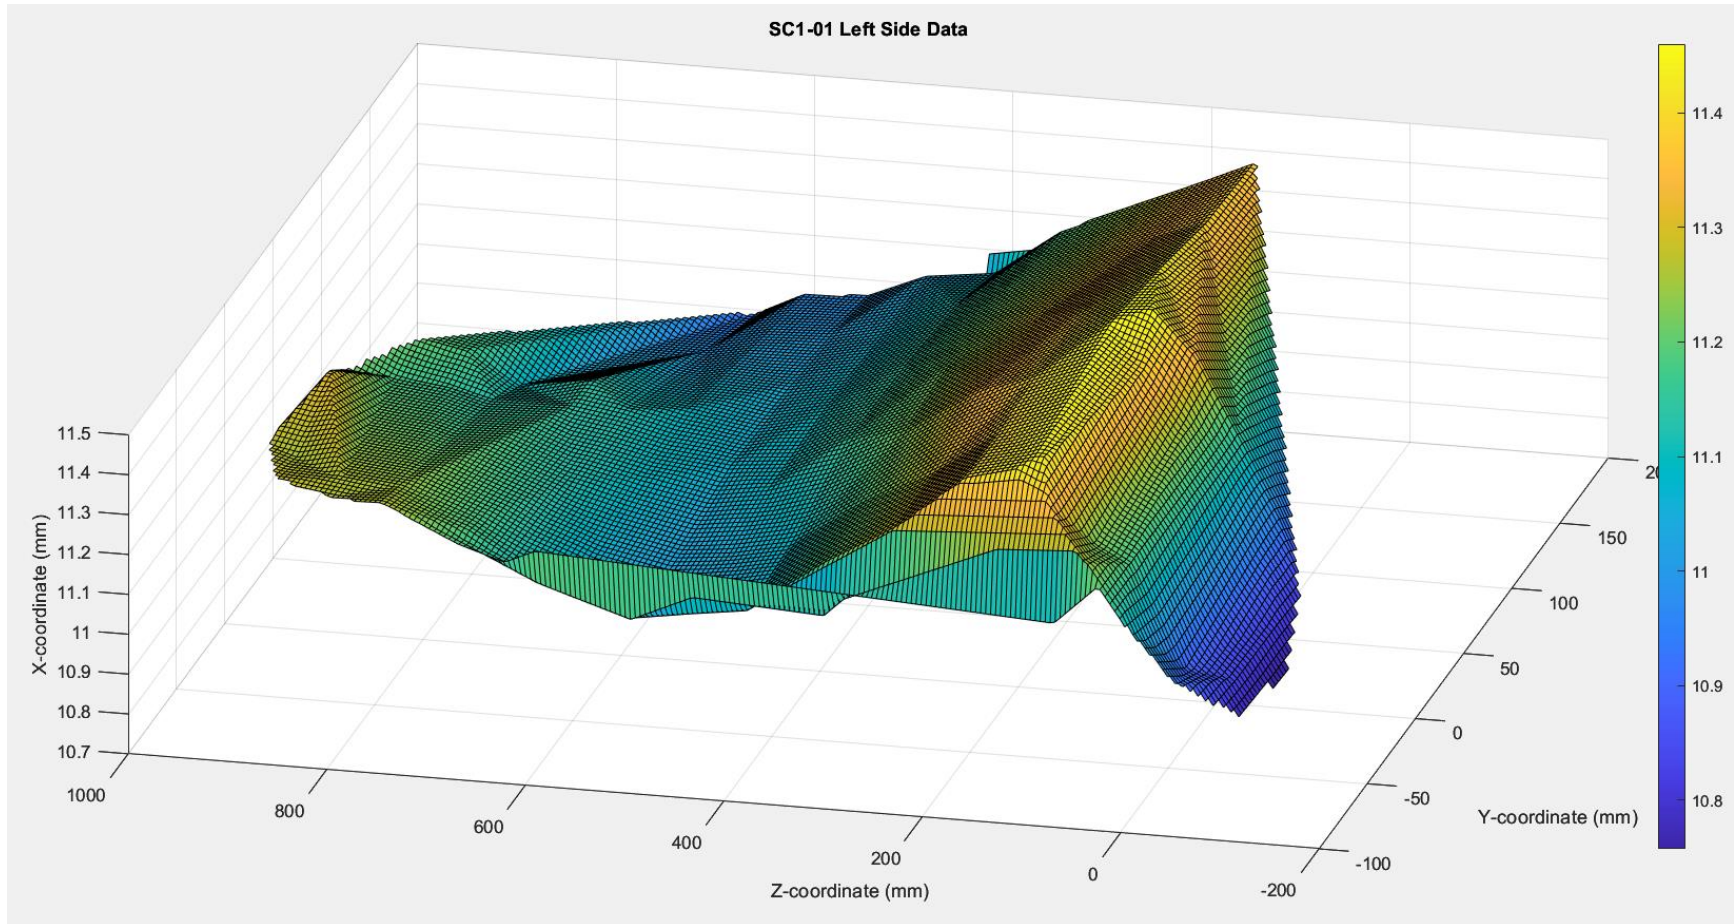
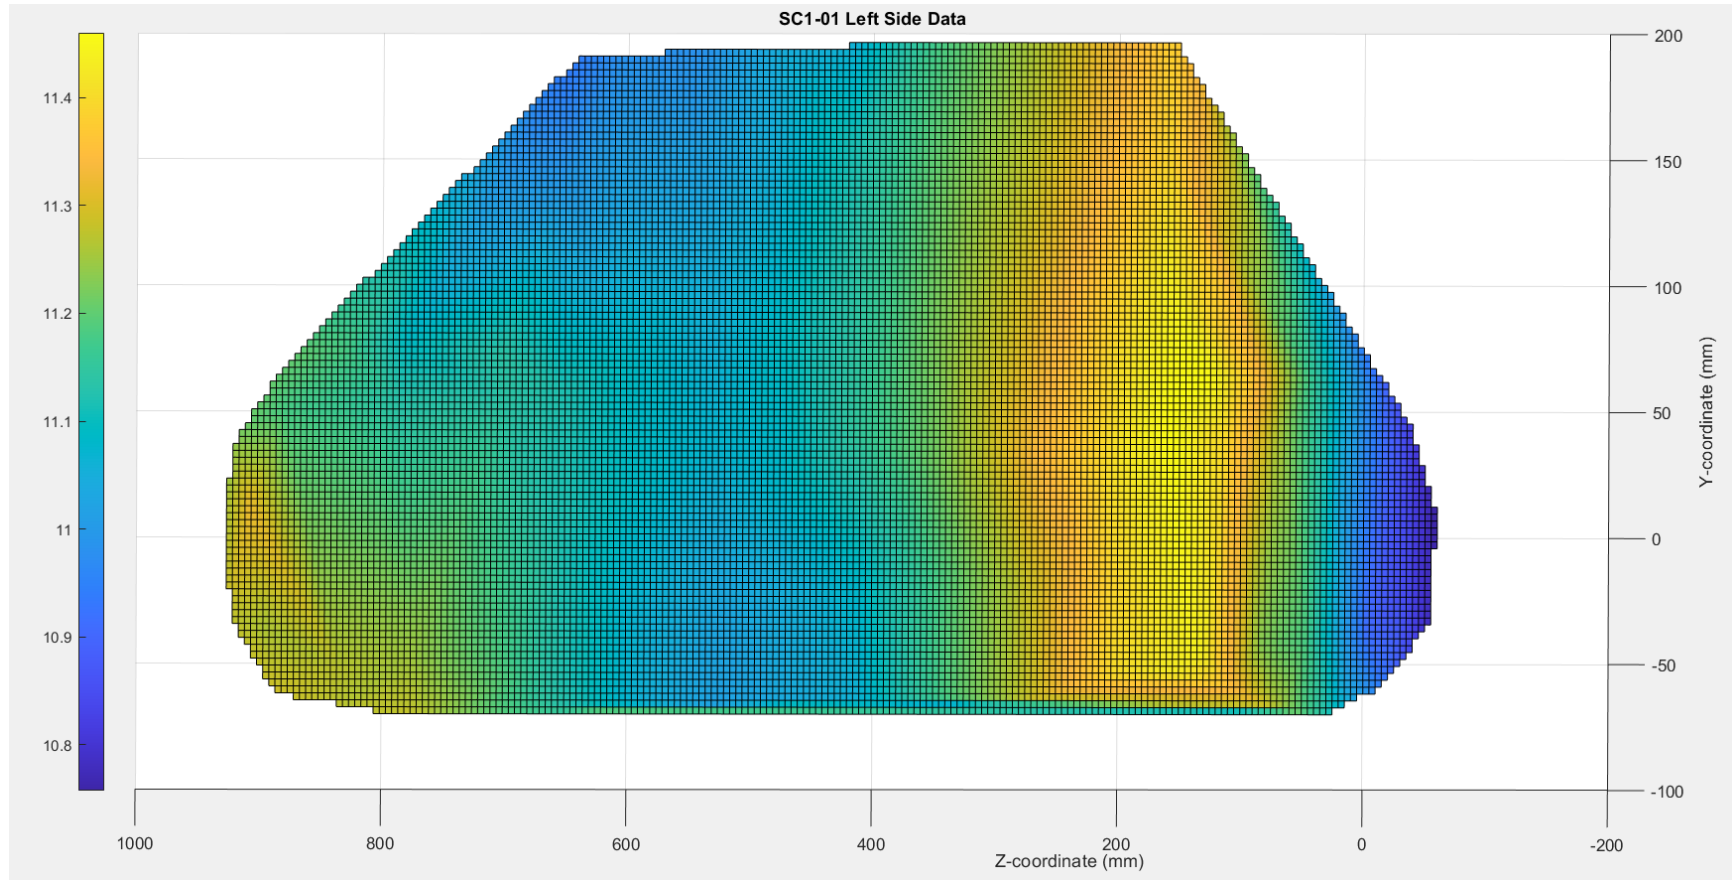
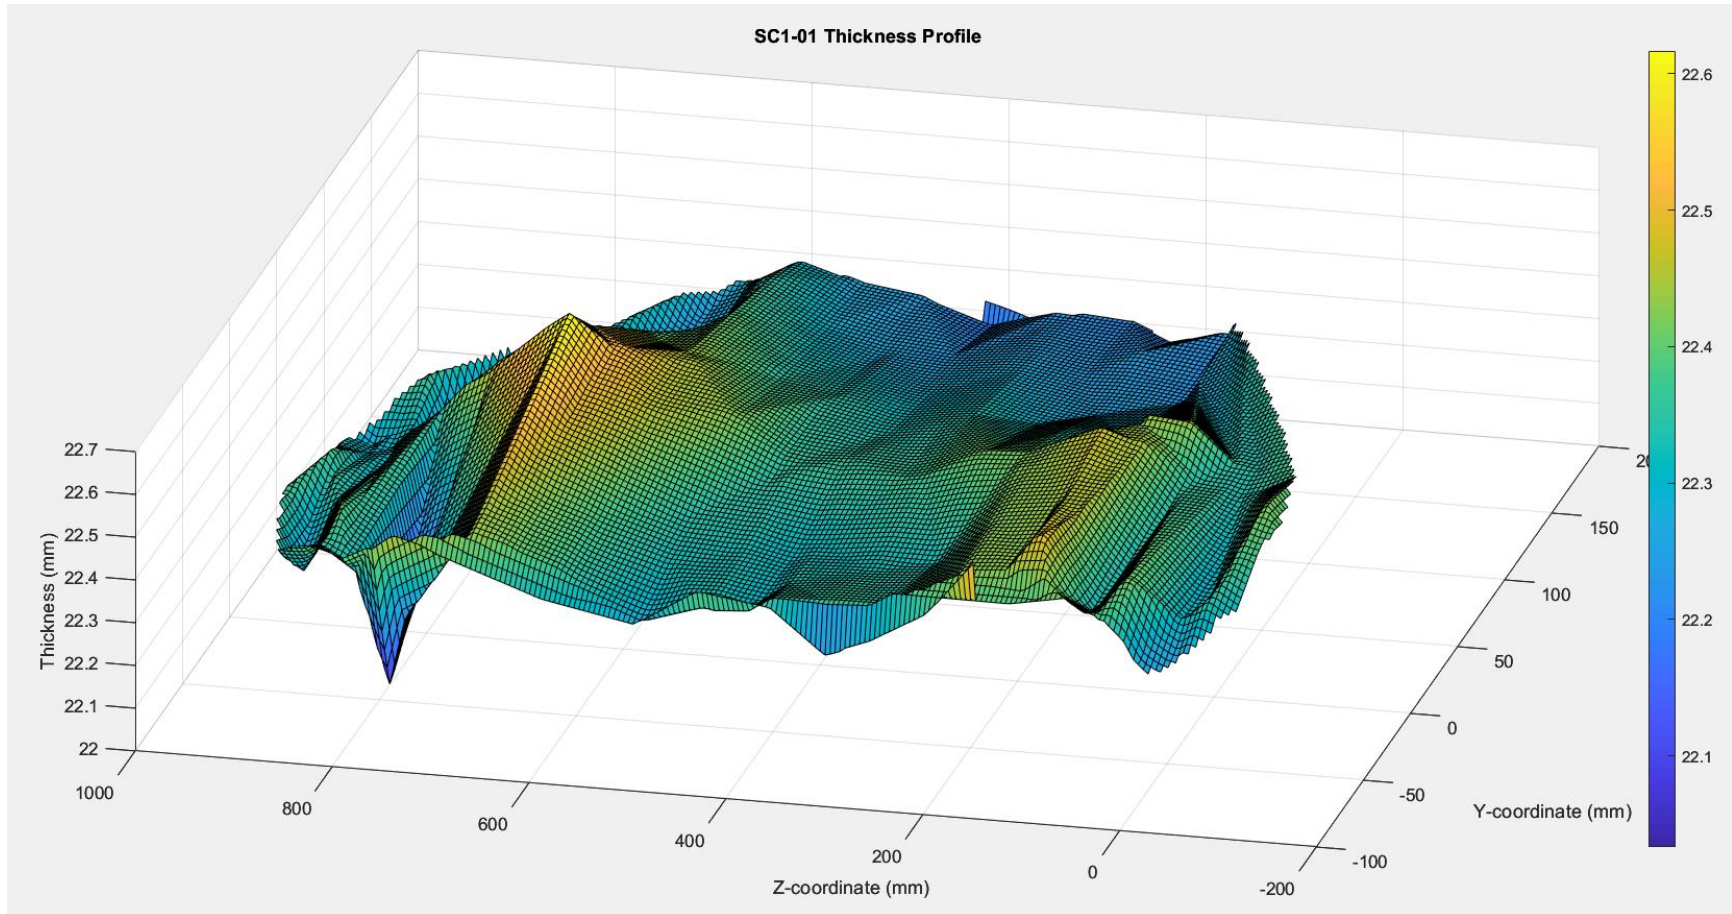
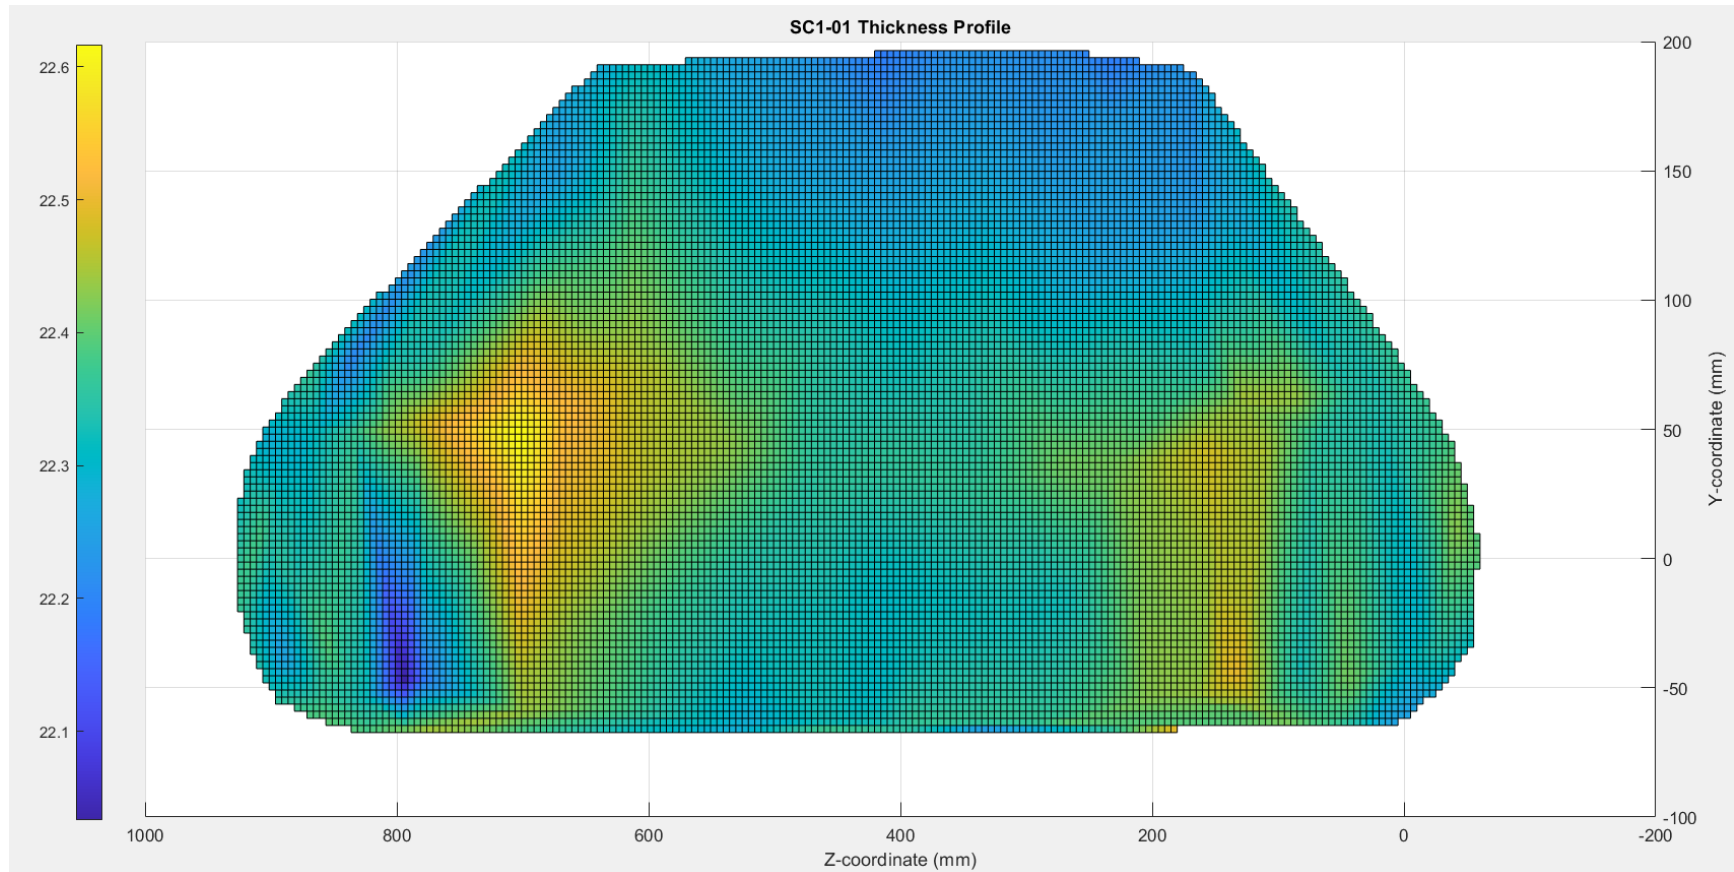
Figure 69 - SC1-01 Right Side Plot, Isometric

Figure 70 - SC1-01 Right Side Plot, Flattened

Figure 71 - SC1-01 Left Side Plot, Isometric

Figure 72 - SC1-01 Left Side Plot, Flattened

Figure 73 - SC1-01 Thickness Plot, Isometric

Figure 74 - SC1-01 Thickness Plot, Flattened
