TITLE: MOLLER Spectrometer – Downstream Torus Magnet Prototype Coil Report on Fabrication and Testing

DOCUMENT NUMBER: PMAG0000-0100-R0035

DATE: April 28, 2023

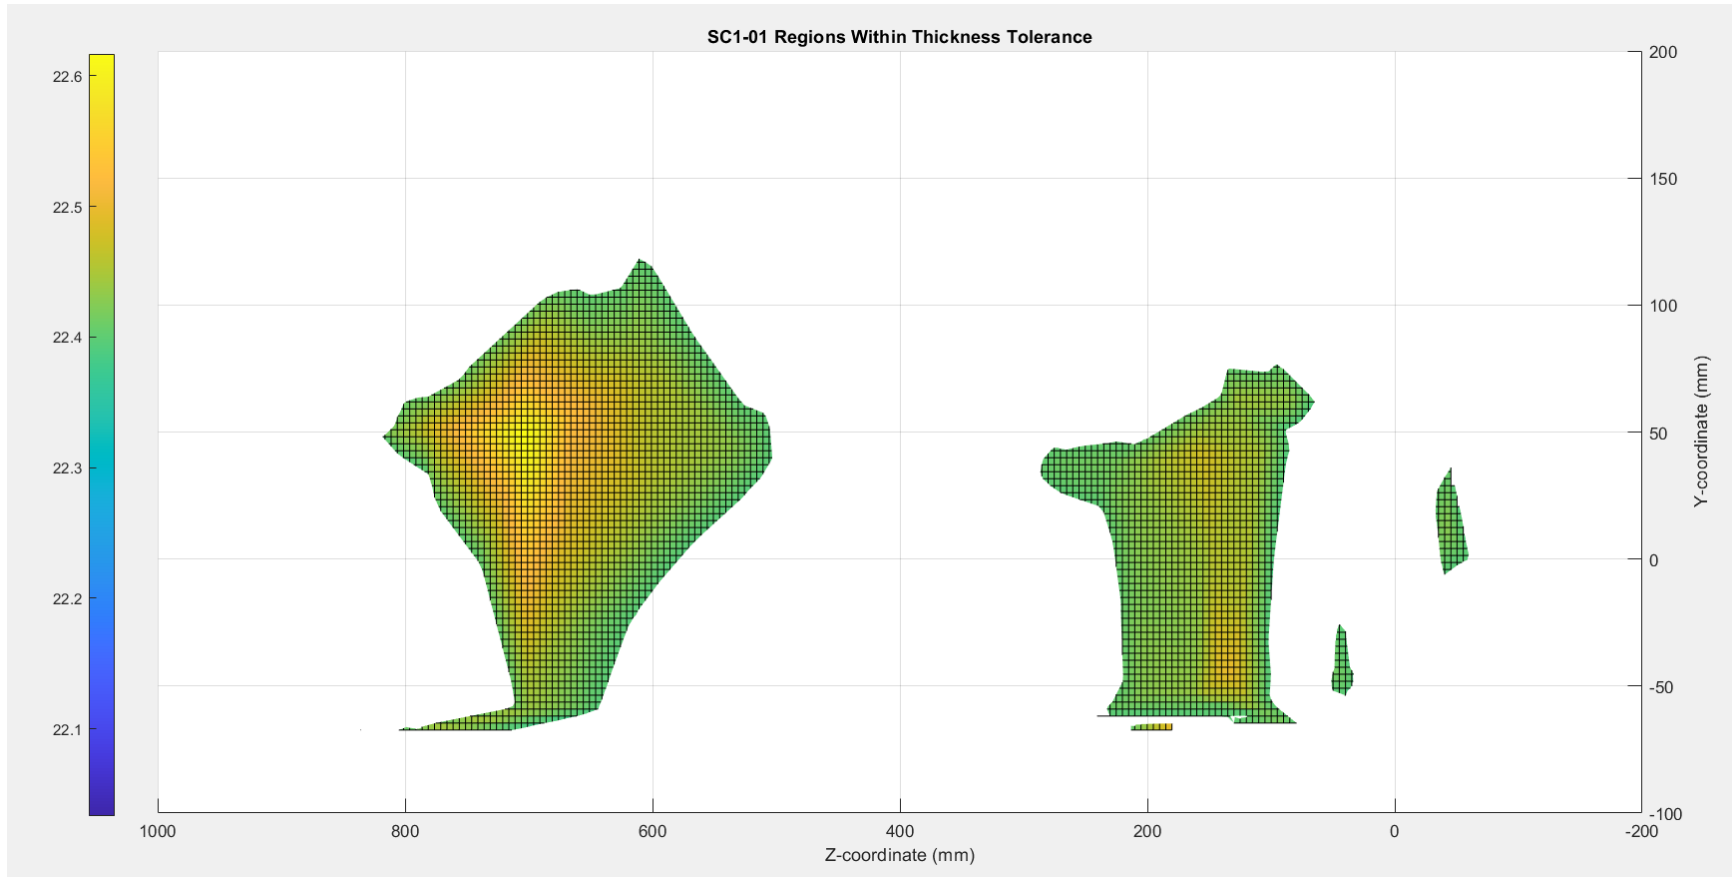
Figure 75 - SC1-01 Regions Within Tolerance

Figure 76 - SC1-01 Out of Tolerance Regions, Thin

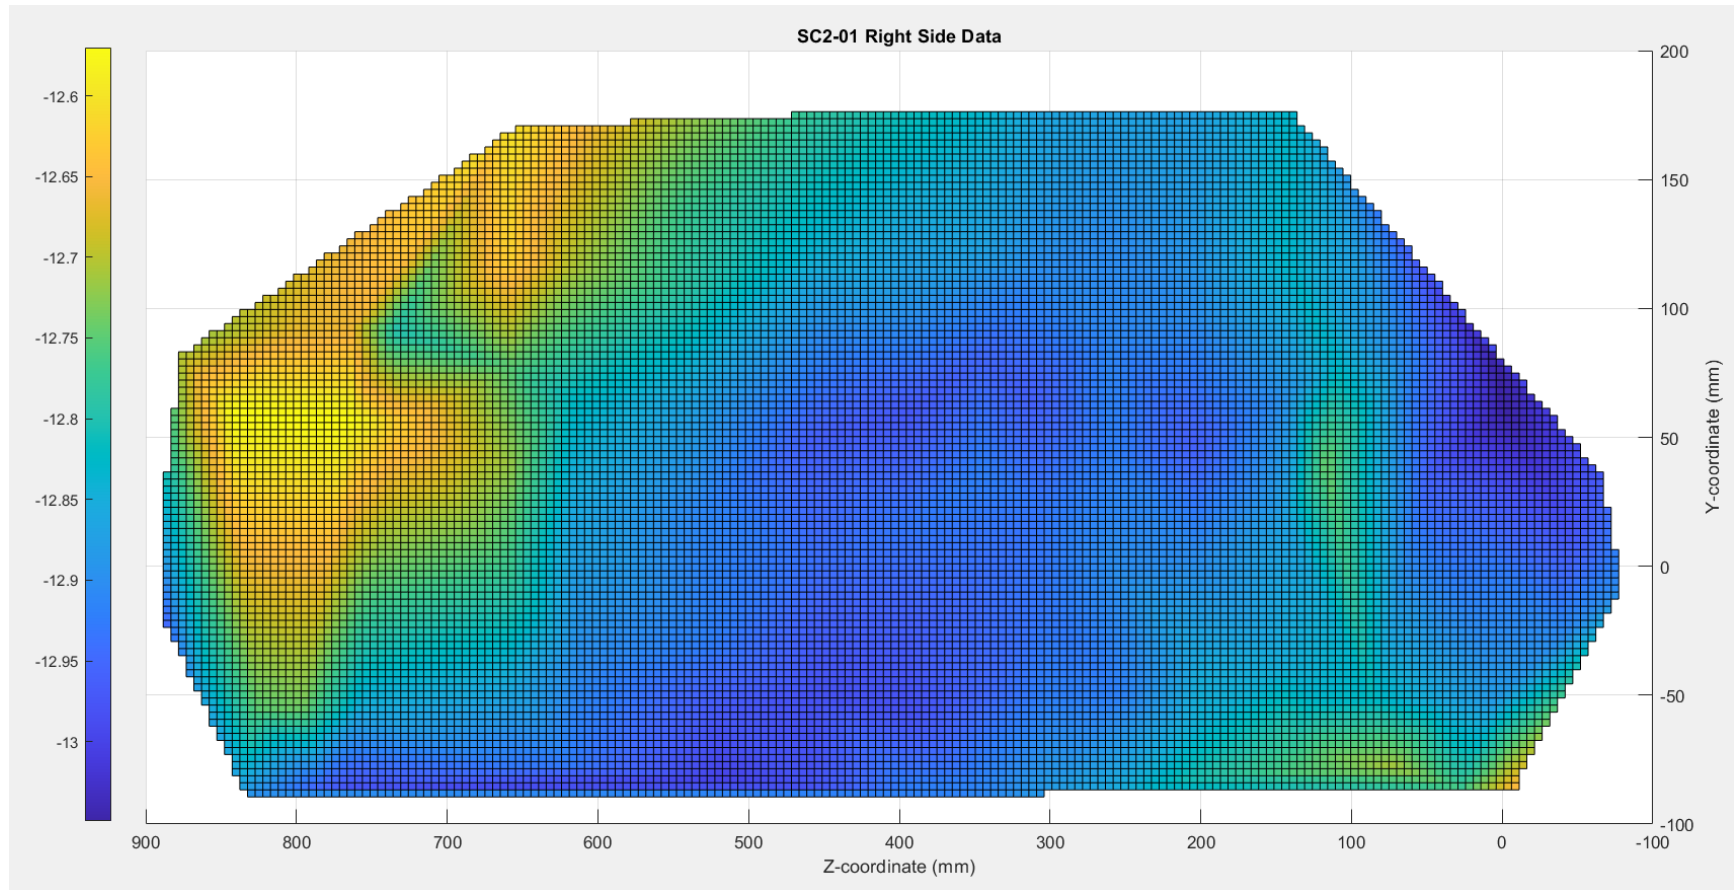
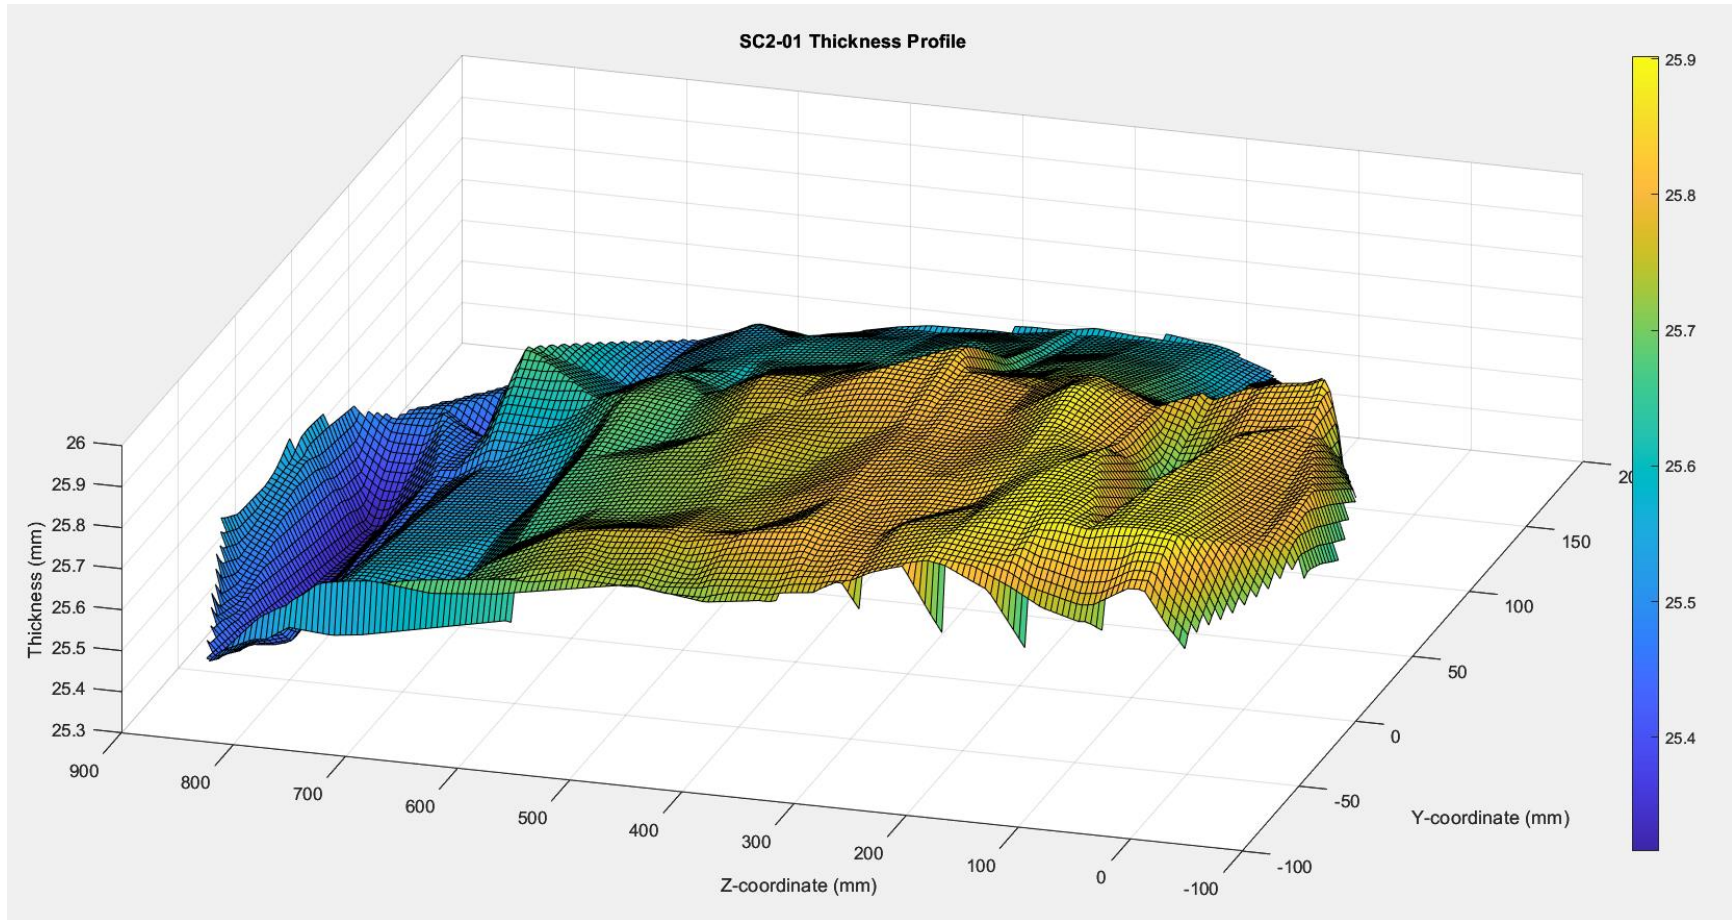
Figure 77 - SC2-01 Right Side Plot, Isometric

Figure 78 - SC2-01 Right Side Plot, Flattened

Figure 79 - SC2-01 Left Side Plot, Isometric

Figure 80 - SC2-01 Left Side Plot, Flattened

Figure 81 - SC2-01 Thickness Plot, Isometric

Figure 82 - SC2-01 Thickness Plot, Flattened

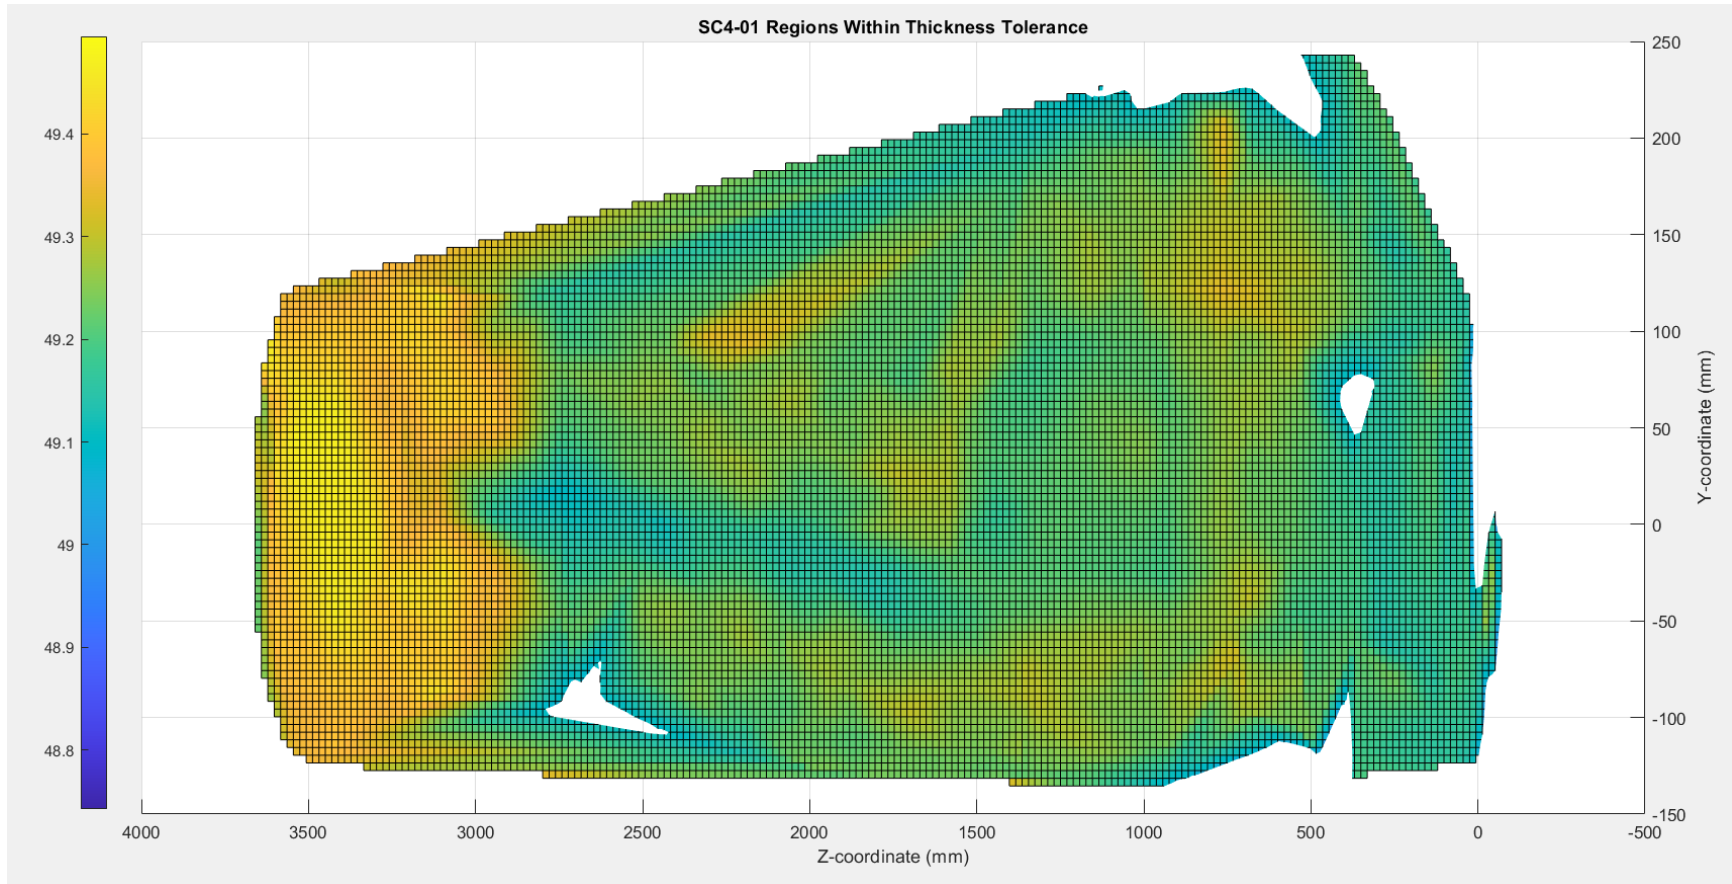
Figure 99 - SC4-01 Regions Within Tolerance

Figure 100 - SC4-01 Out of Tolerance Regions, Thin
